Bat Survey Report

North Farm, Elwick

Fordy Marshall Ltd.

October 2015

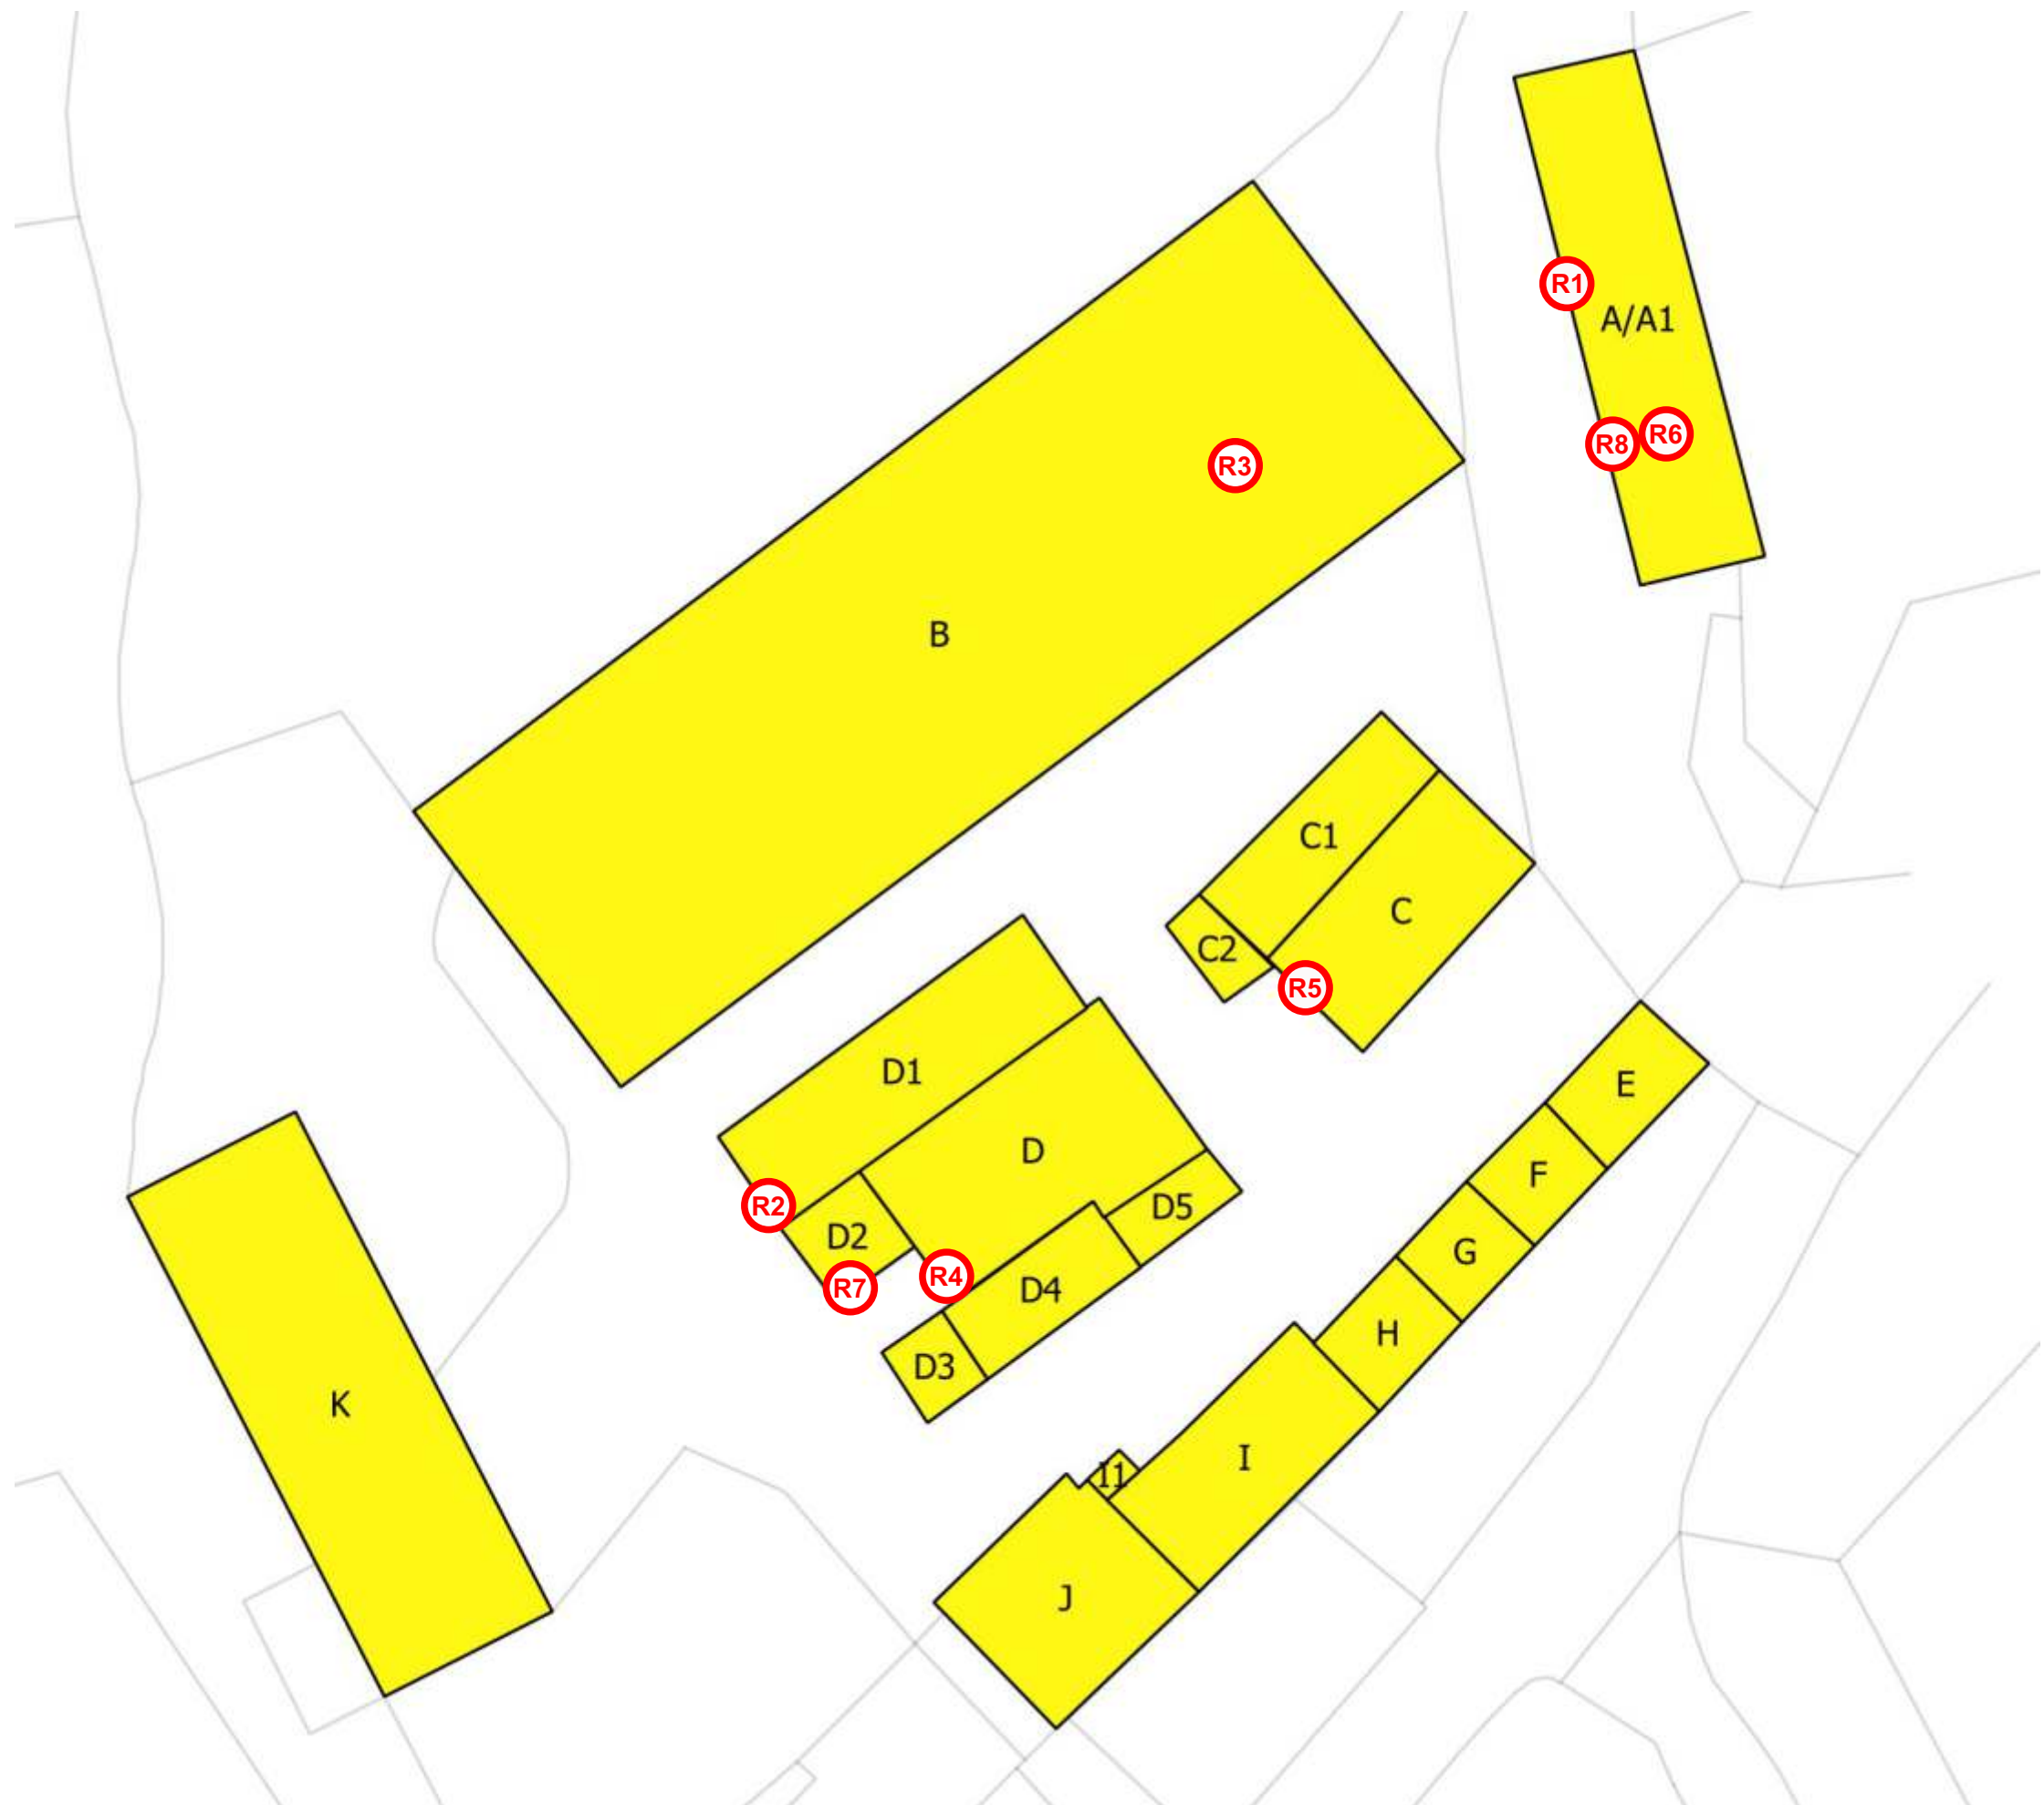
Project	North Farm, Elwick
Title	Roost Locations
Client	Fordy Marshall Ltd.
Date	28th September 2015
Ref	Figure 4

- 1.1.6. Eight small common pipistrelle roosts were identified during the surveys; seven of these, in buildings A, B, C, D, D1 and D2 were identified during the initial dawn re-emergence survey on the 7th September. The roost in building D2 was subsequently identified on the following dusk emergence survey on the 17th September, when an additional roost was identified in Building A was also identified.

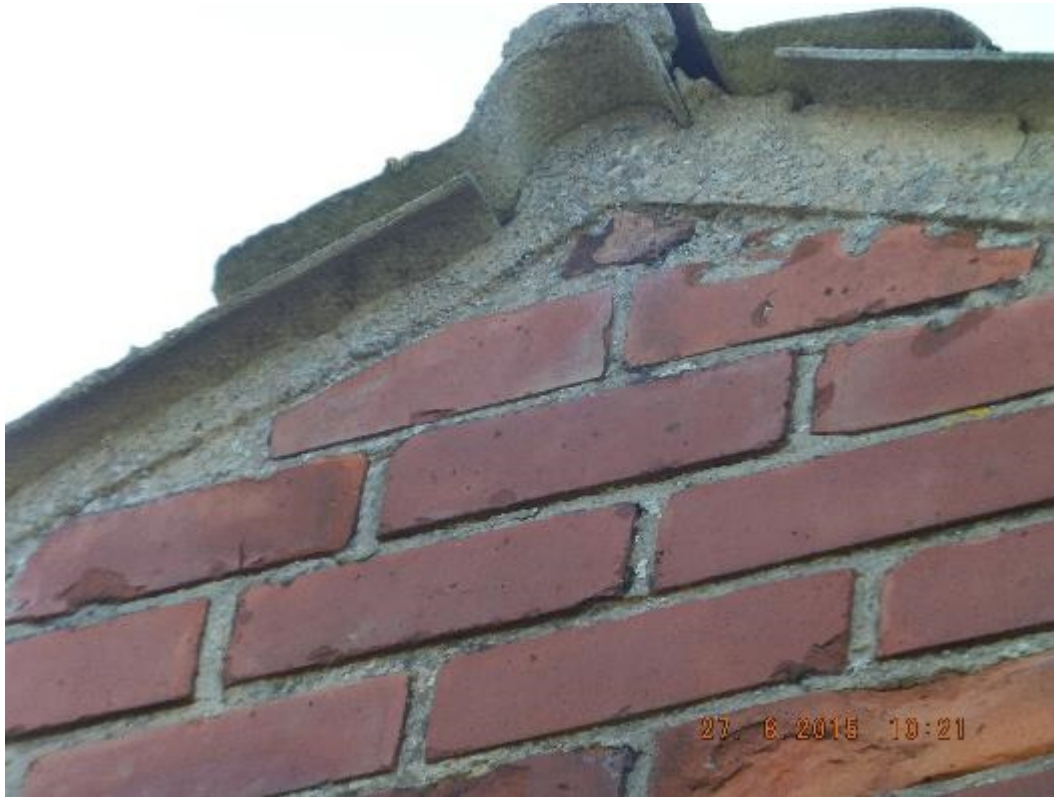
Photograph 13 Potential bat access point: Building A, gap at apex of northern gable

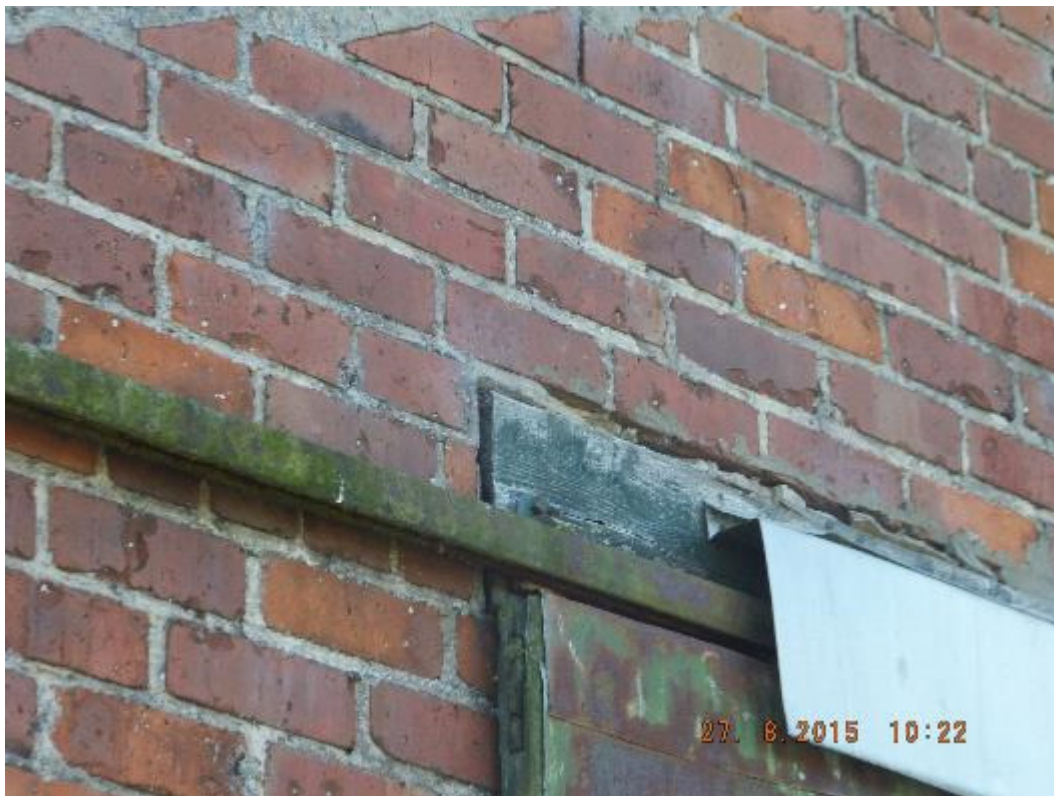
Photograph 14 Potential Bat access: Building A, gap above sliding door

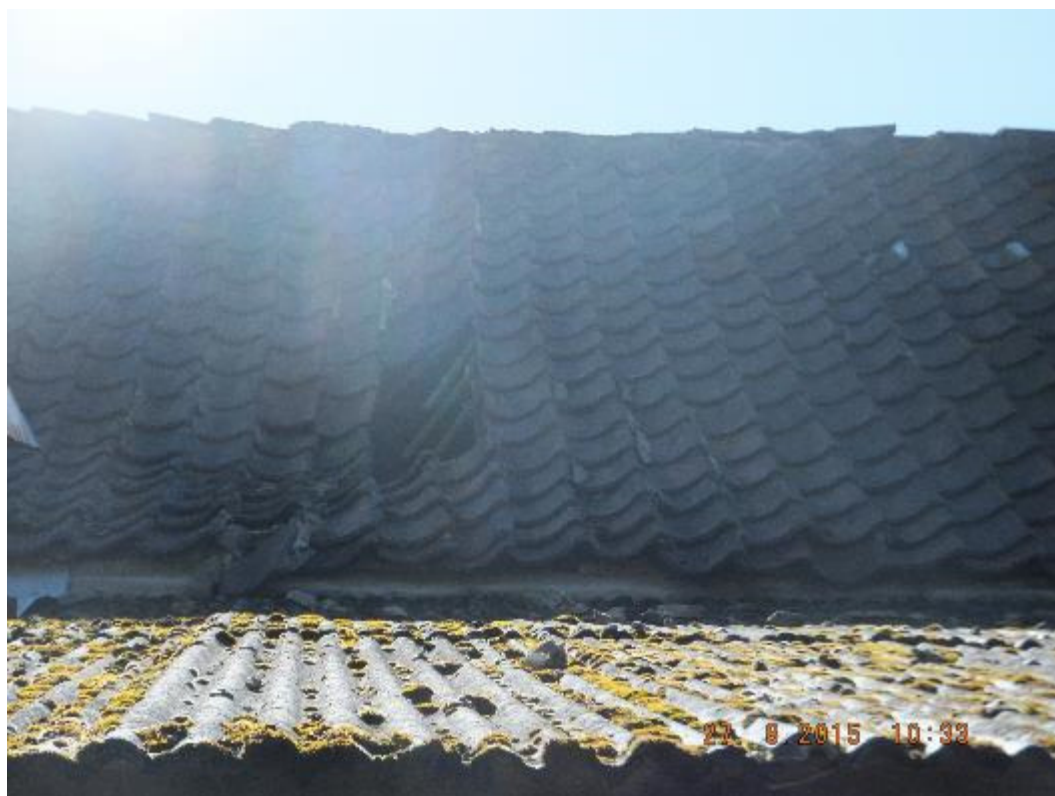
Photograph 16 Hole in roof of Building C

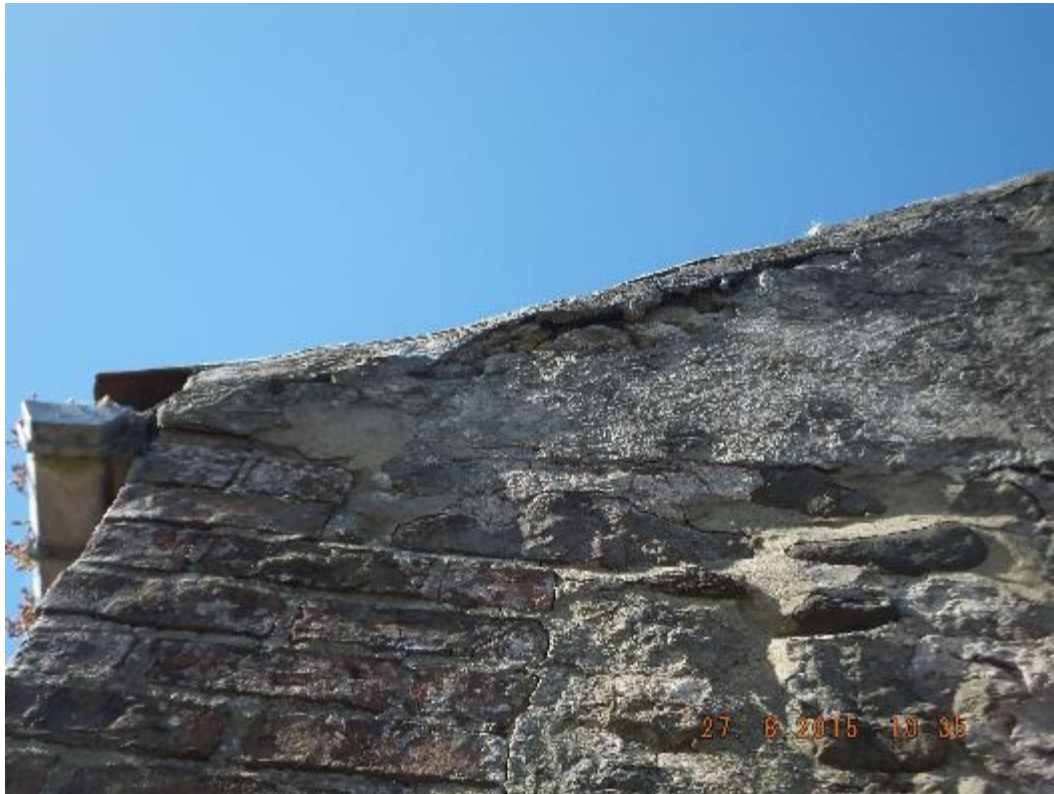
Photograph 17 Gap under mortar Building C, east elevation

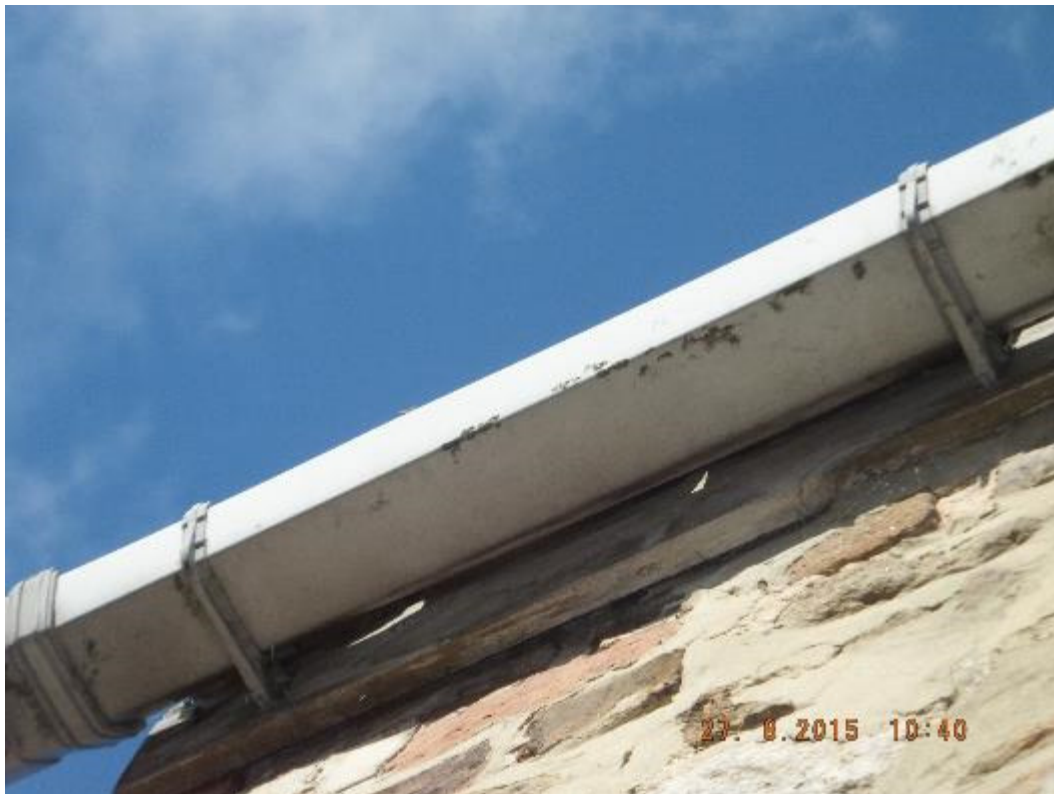
Photograph 18 Potential bat access point, Building C gap under fascia board

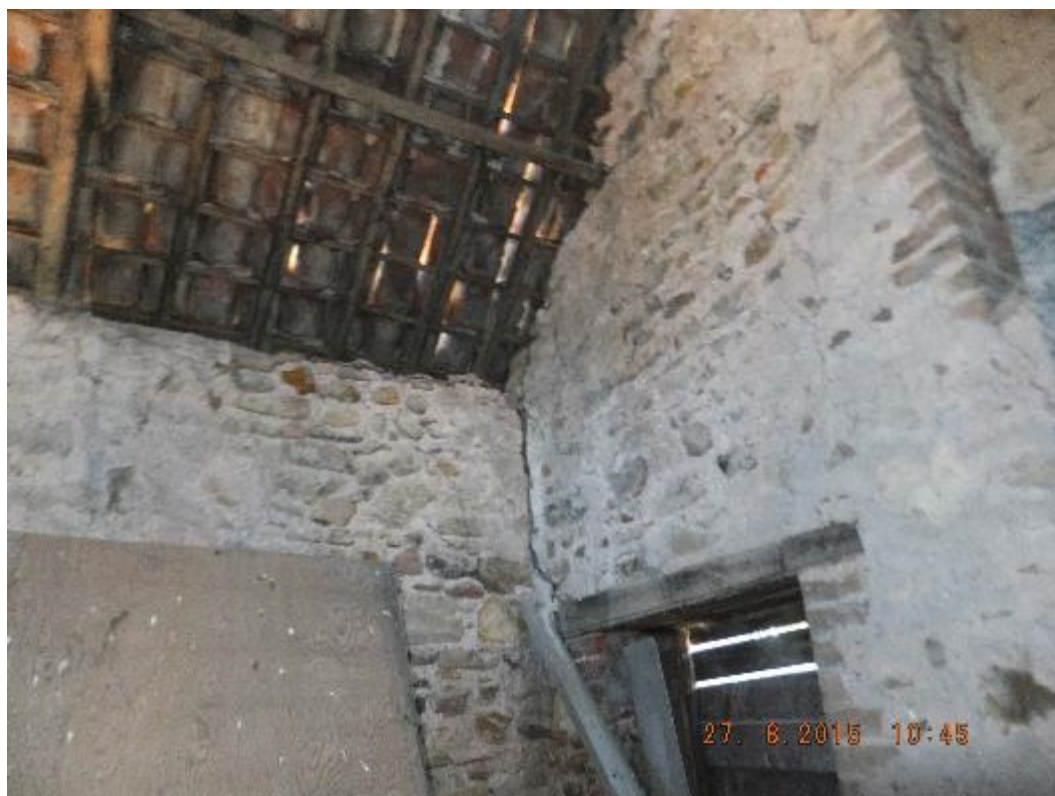
Photograph 19 Interior of C gaps in tiles and cracks in interior walls noted.

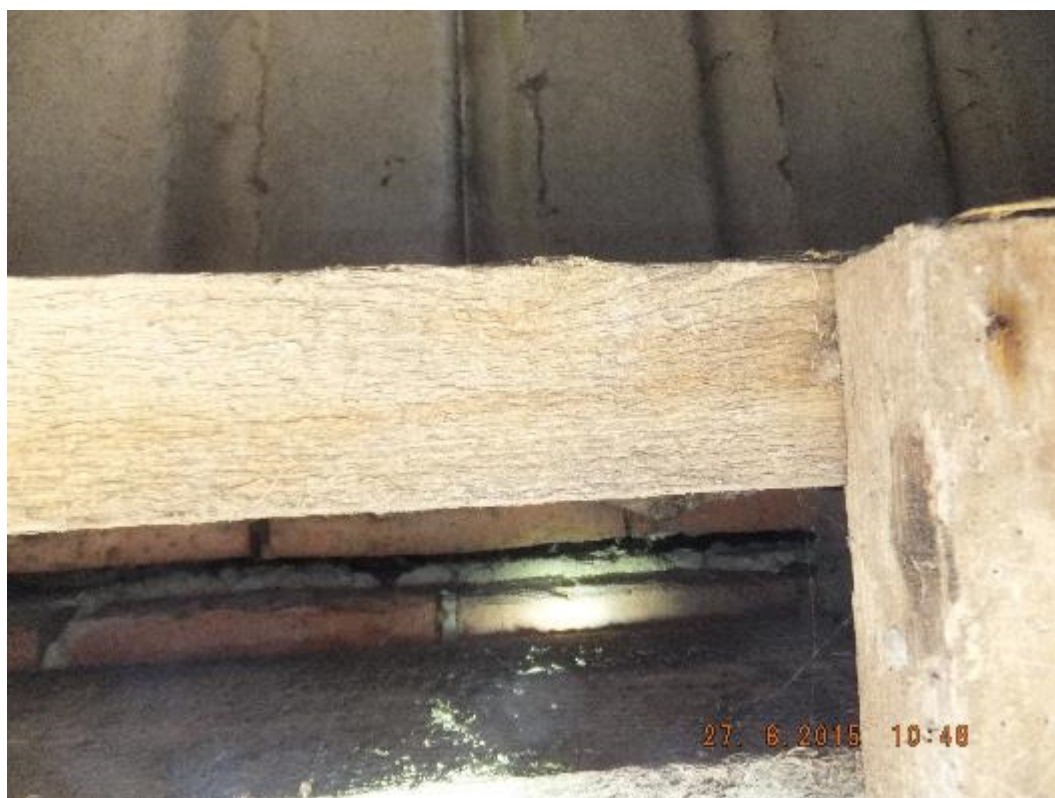
Photograph 20 Potential bat access point Building C2 – gap in brickwork above door

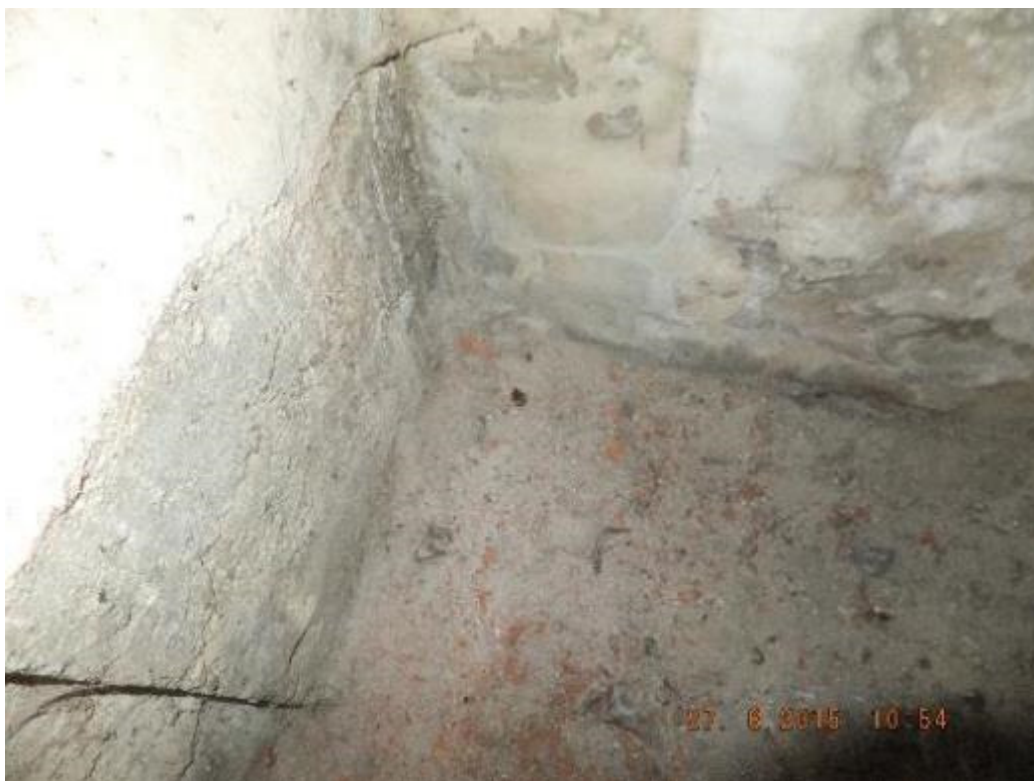
Photograph 21 Evidence of bat use in building C1: Bat dropping and a butterfly wing

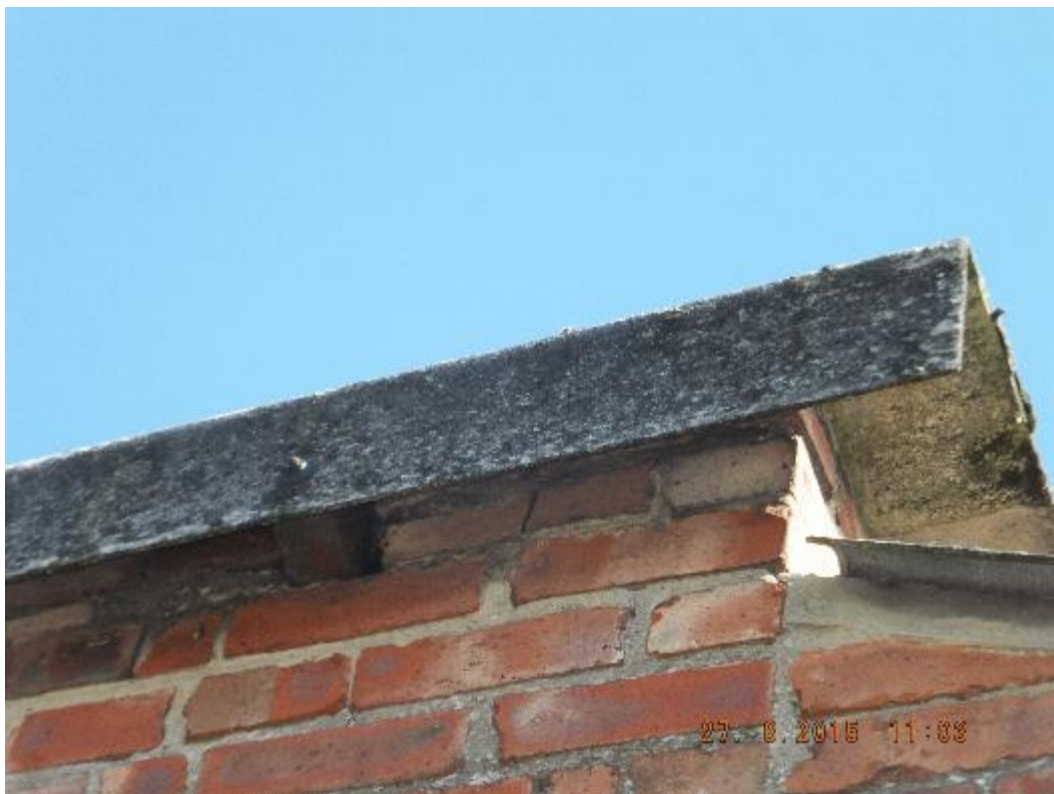
Photograph 22 Potential bat access Building D1 western elevation under overhanging roof

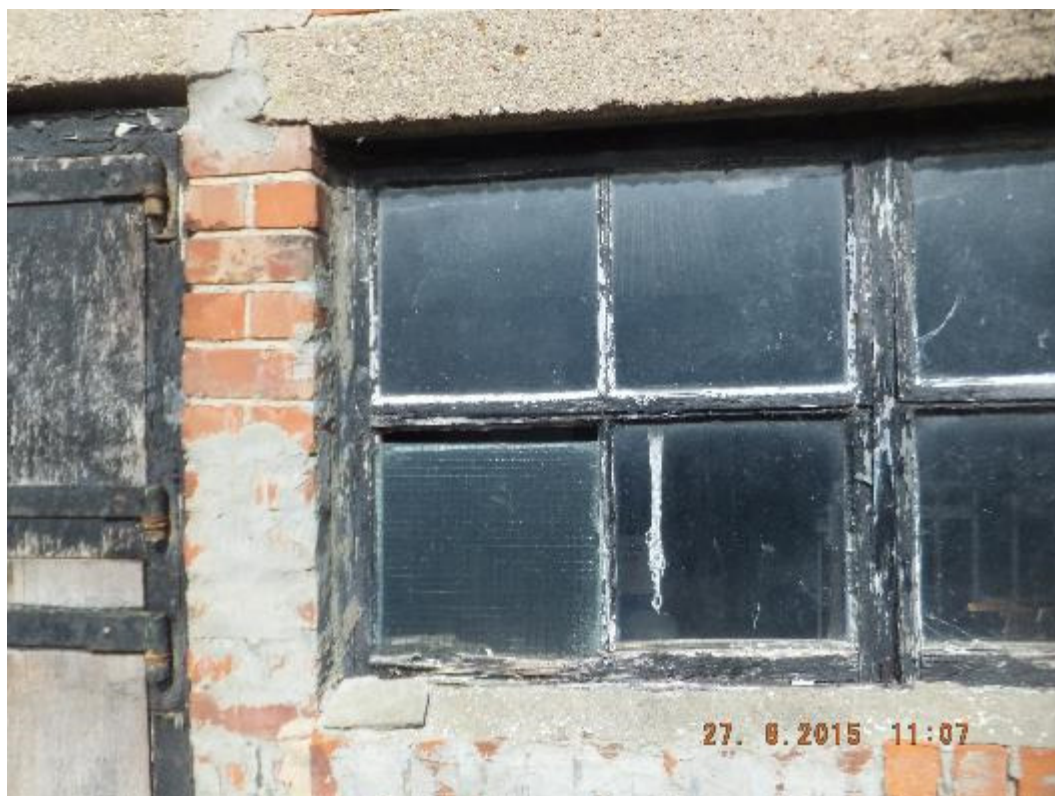
Photograph 23 Potential bat access Building D4, slipped pane of glass

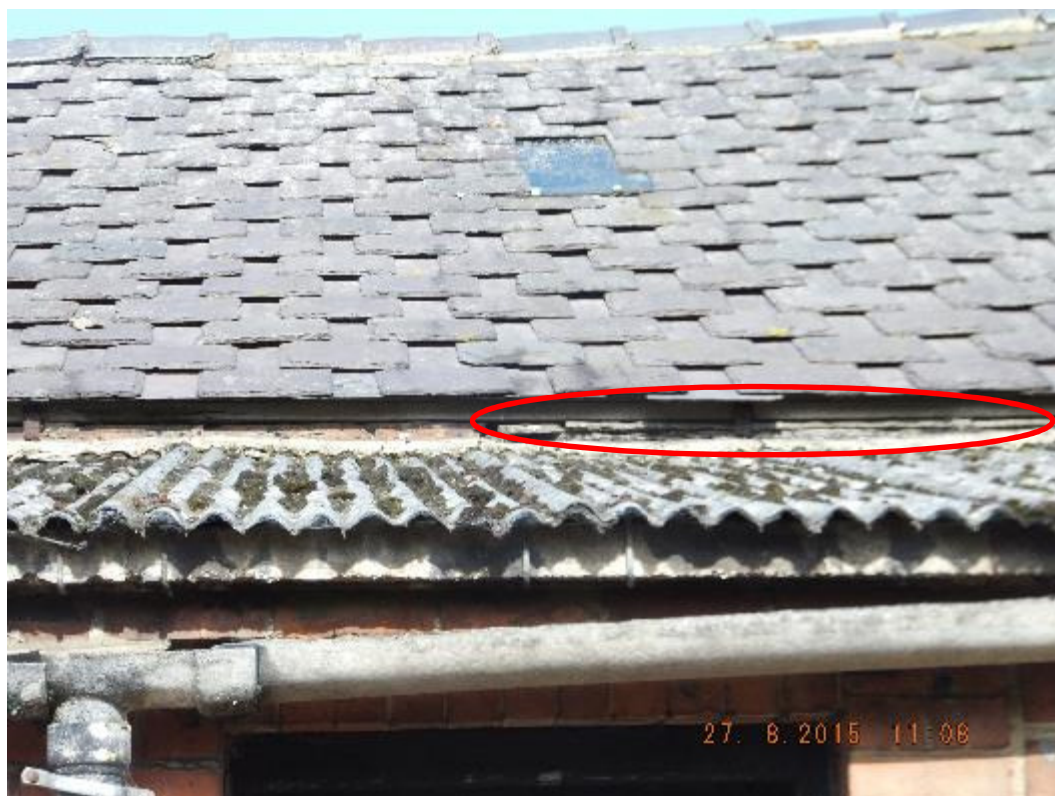
Photograph 24 Potential bat access under tiles building D

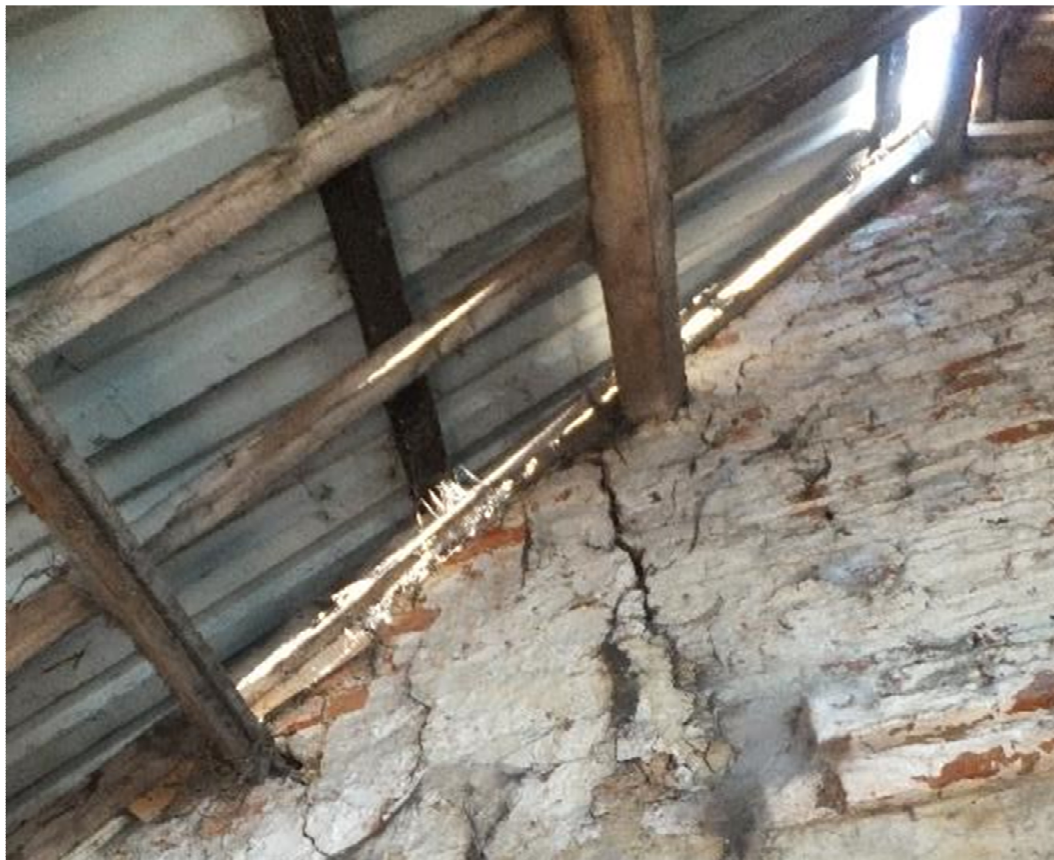
Photograph 26 Potential bat roosting point crack in in building F

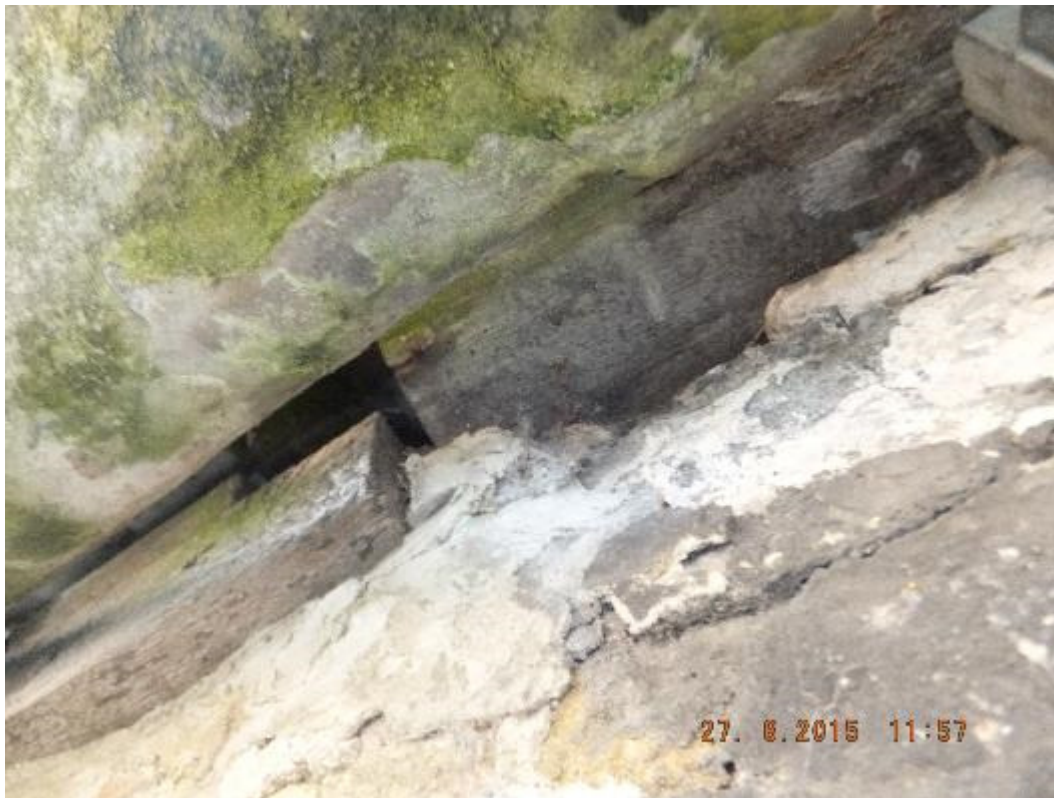
Photograph 27 Potential bat access point Building H gap at wall top

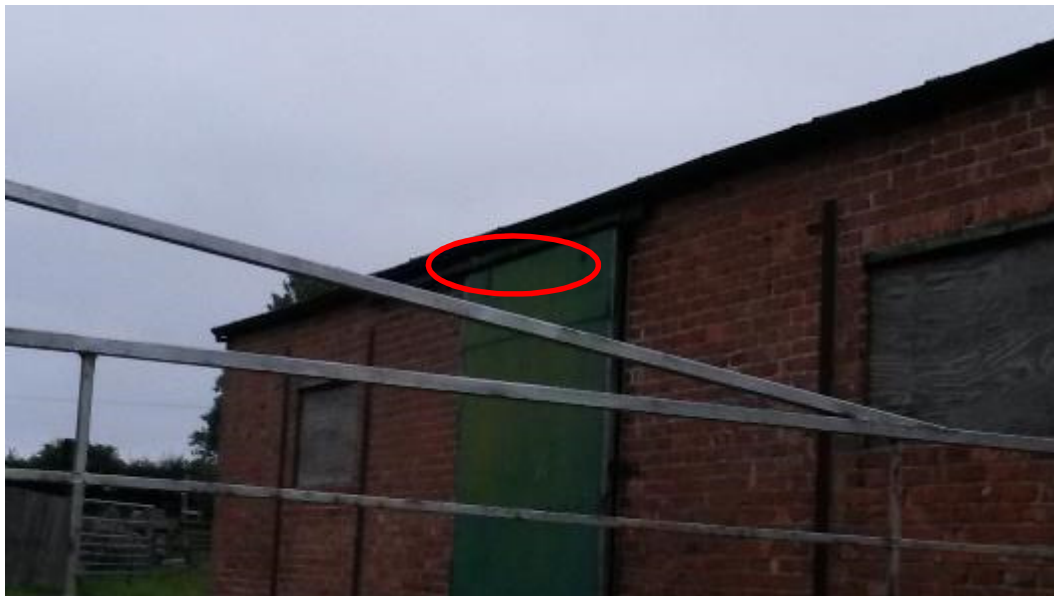
Photograph 28 Location of Roost 1, west elevation of Building A

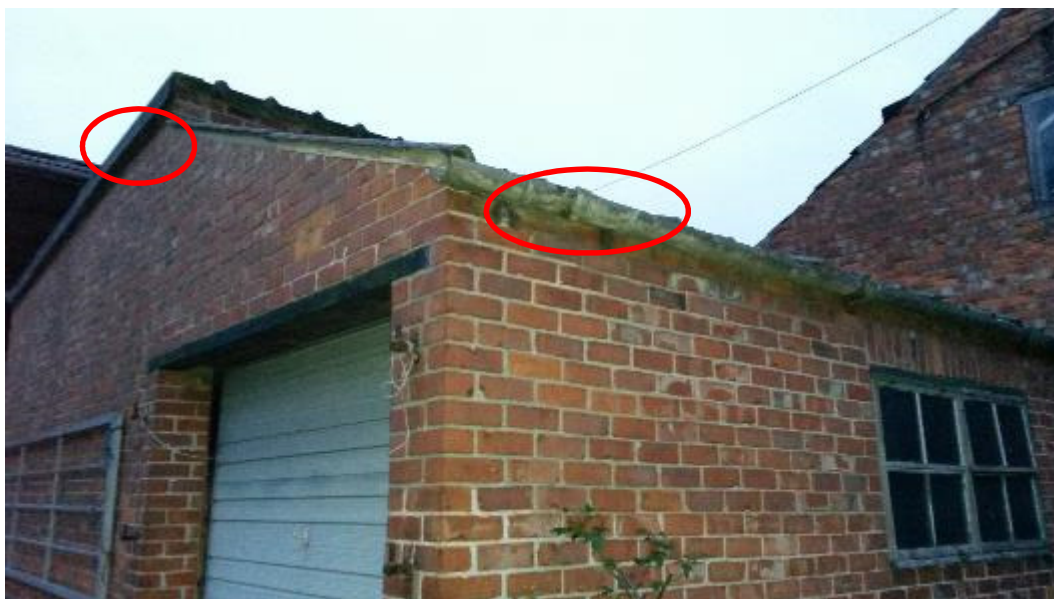
Photograph 29 Location of Roosts 2 and 7, west facing gable of Building D1 and southern elevation of Building D2

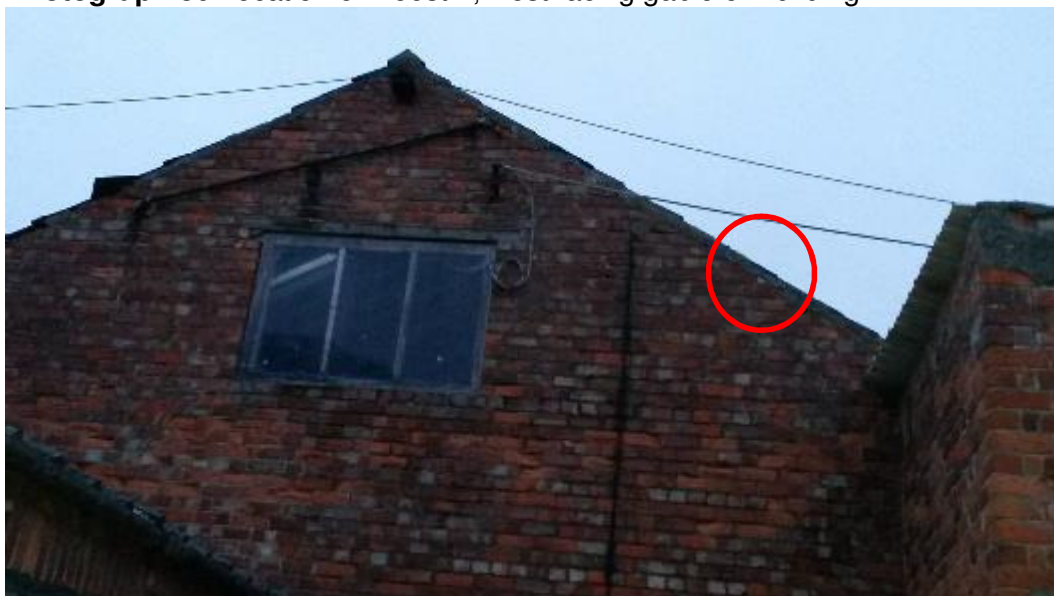
Photograph 30 Location of Roost 4, west facing gable of Building D

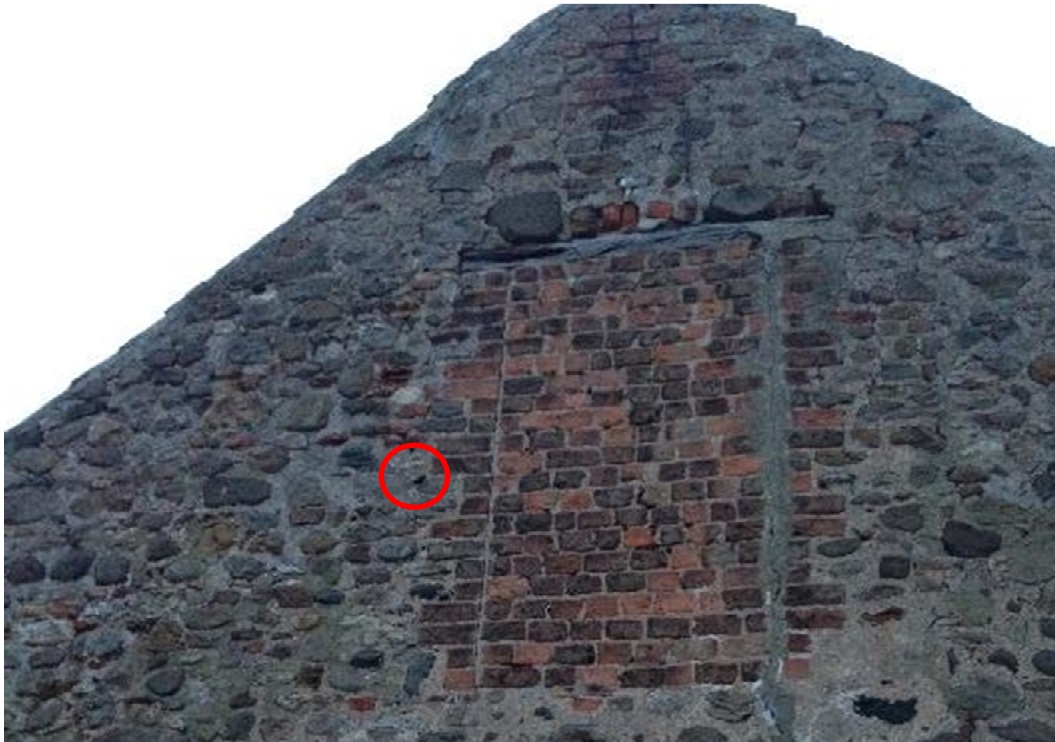
Photograph 31 Location of Roost 5, west facing gable of Building C

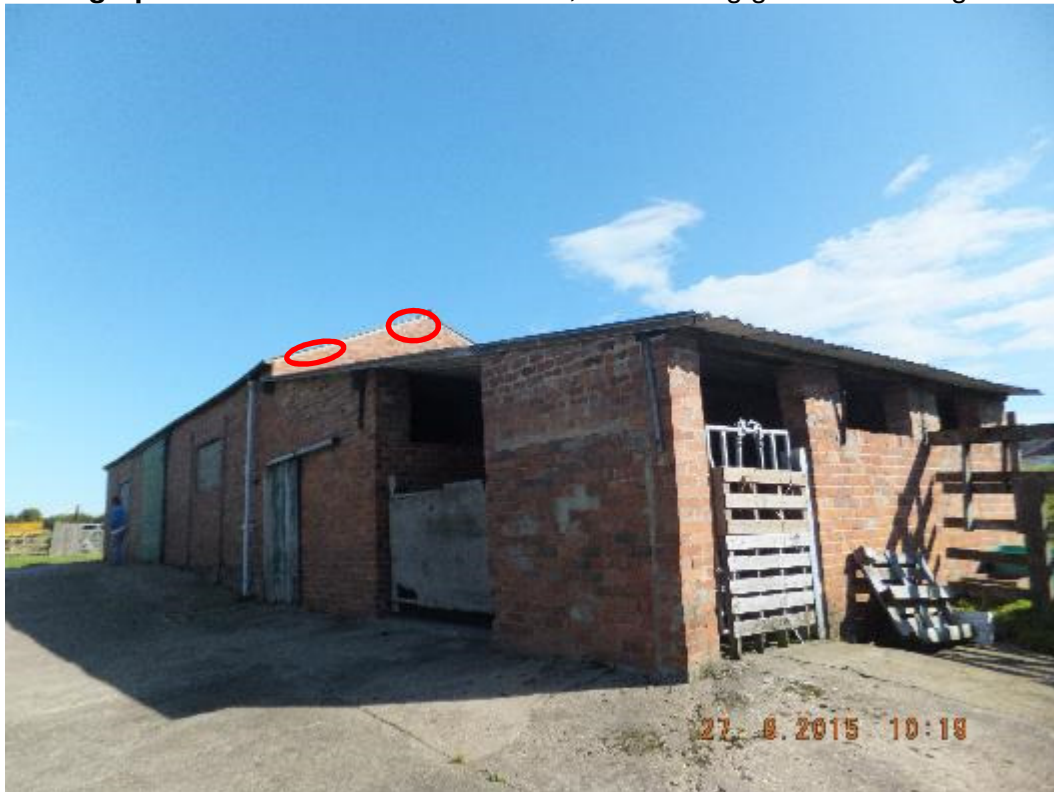
Photograph 32 Location of Roosts 6 and 8, south facing gable of Building A
