Planning Potential

**Westholme Road, Masham**  
*Phase I Geoenvironmental Desk  
Study – Revision 2*

March, 2017

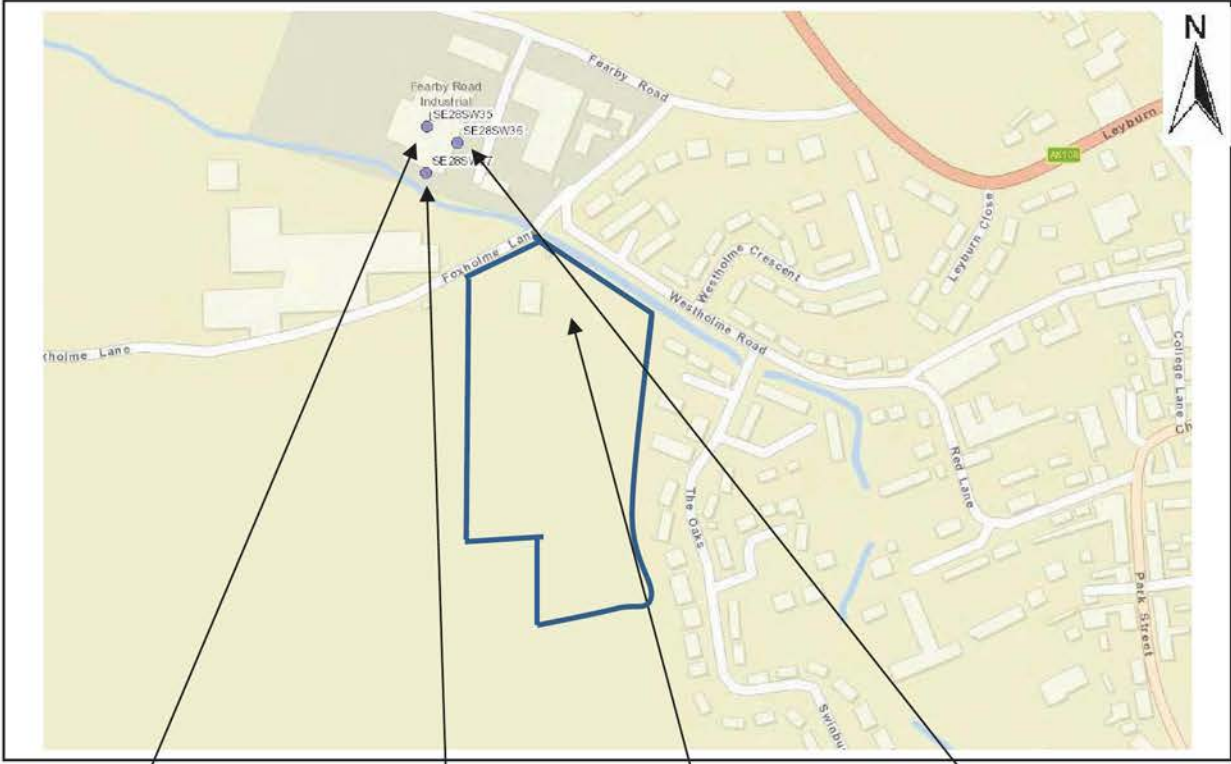
The published geology of the area is generally confirmed by nearby available historical borehole logs, which have been obtained from the BGS and are summarised in Table 3 below. The locations relative to the site are shown in Figure 3.

Borehole  
SE28SW35

Borehole  
SE28SW37

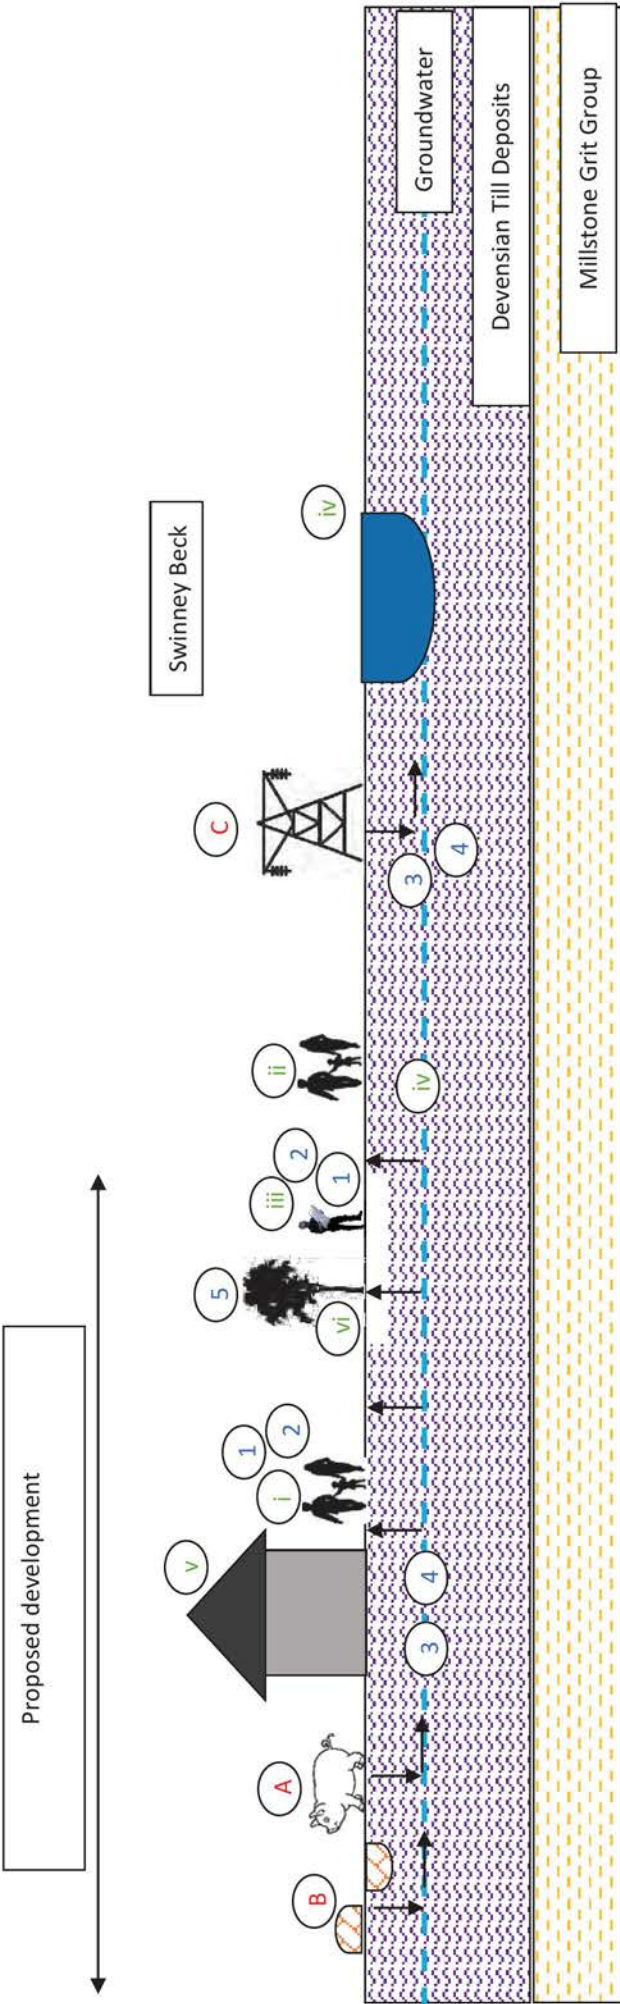
Client <b>Planning Potential on behalf of G &amp; C Jameson</b>	Project <b>Westholme Road, Masham</b>	Job No <b>CGN/03835</b>
 	Title <b>Preliminary Conceptual Site Model</b>	Figure 4

**Potential Pathways**  
 1 – Ingestion and inhalation  
 2 – Direct/dermal contact  
 3 – Drainage and services  
 4 – Geological pathways  
 5 – Root uptake  
 6 – Vegetation

**Potential Receptors**  
 i – Future site users  
 ii – Off-site occupiers  
 iii – Construction Workers  
 iv – Controlled waters – Swinney Beck/ Secondary A and Undifferentiated Aquifer  
 v – Future buildings and structures  
 vi – Vegetation

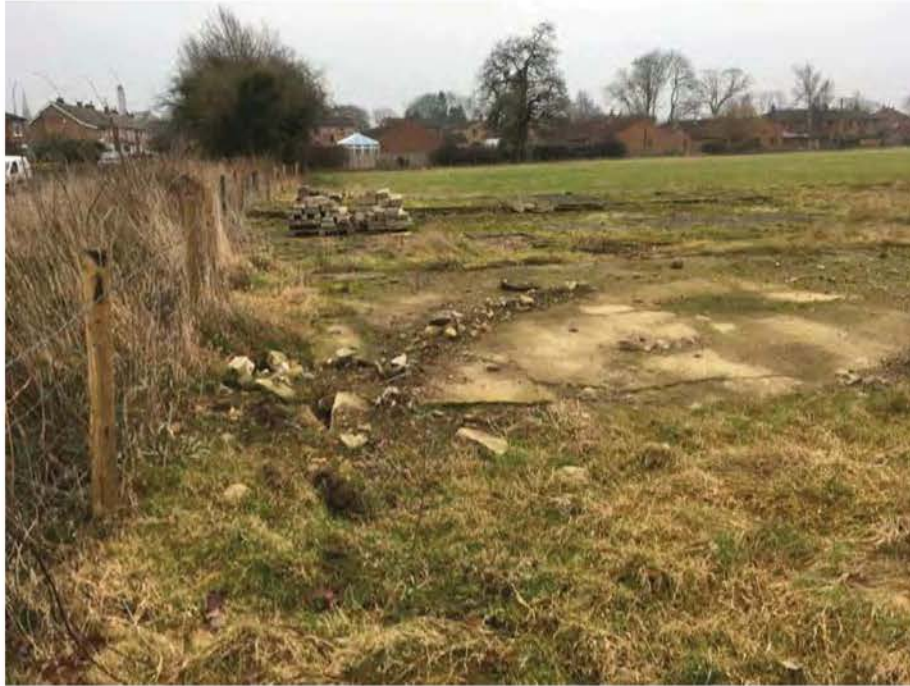
Date	Job No	Made by	Checked by	Sheet No
January 2017	CGN/03835	AP	JAS	01

View of the concrete slabs, as viewed looking east along the northern border.

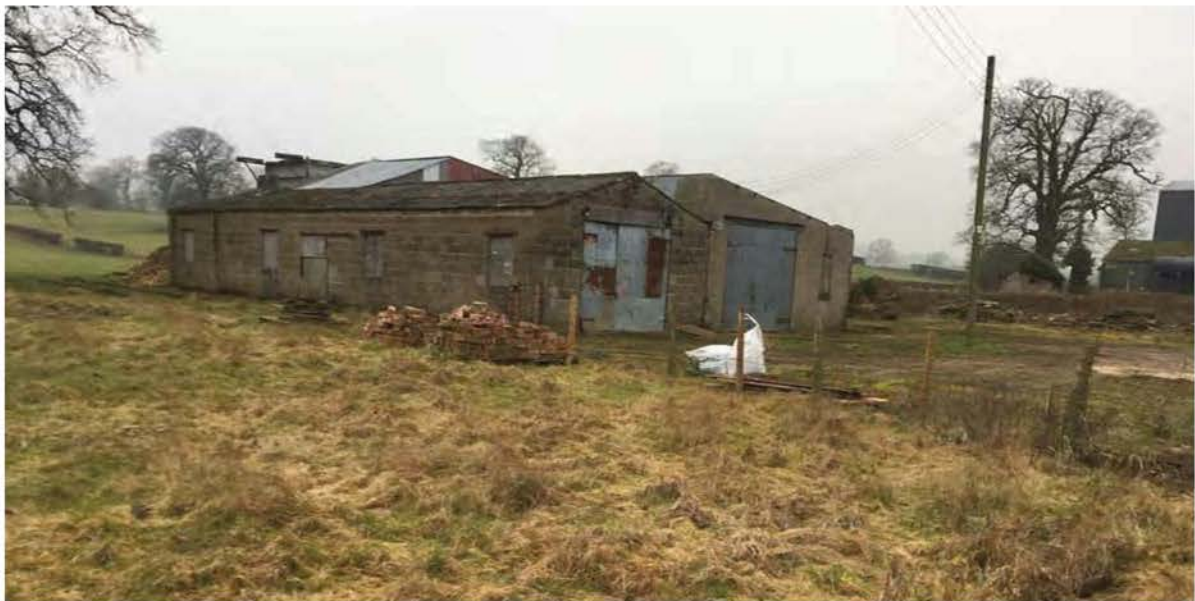
View looking south west, from the northern boundary, of the larger structure. Potential asbestos has been identified in the roof of the structure. Overhead line services seen running into the building.

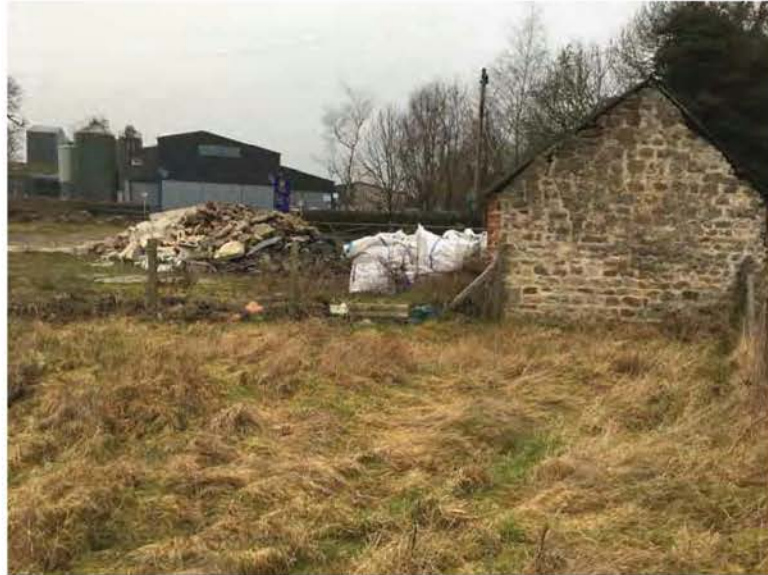
Date	Job No	Made by	Checked by	Sheet No
January 2017	CGN/03835	AP	JAS	02

View looking west, along the northern boundary of the site. Second smaller dilapidated structure visible with pile of building rubble/concrete next to it, potentially containing asbestos fibres. Animal feed manufacturer/supplier plant (client) visible in distance.

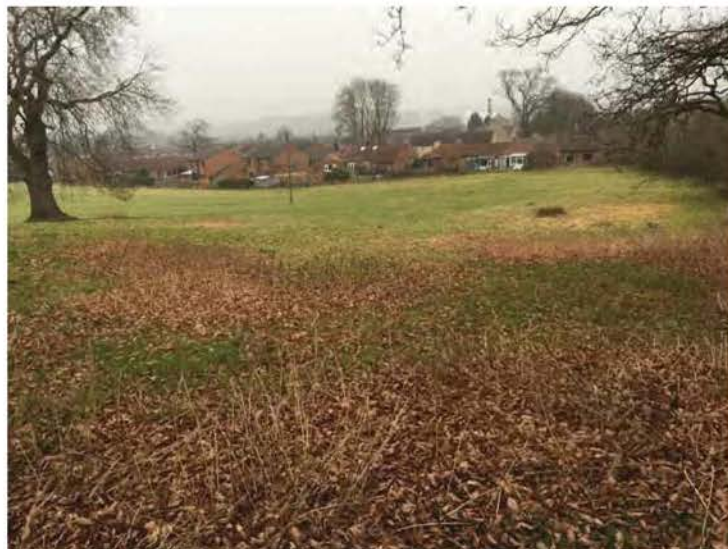
View from elevated south west corner of site, showing southern grassland area. Potential for this topsoil to be reused as part of the development scheme.

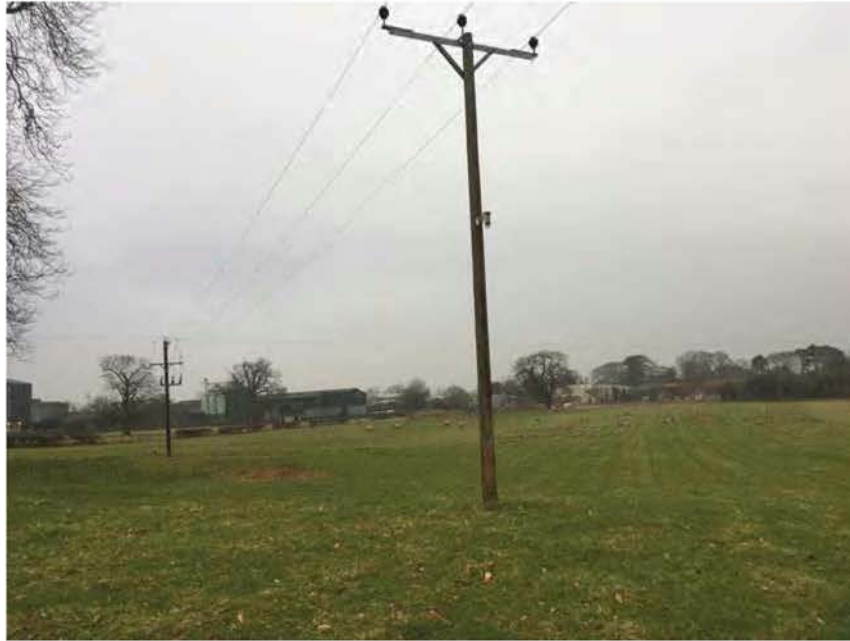
Date	Job No	Made by	Checked by	Sheet No
January 2017	CGN/03835	AP	JAS	03

View looking north. Two telegraph poles running north west across the centre of the site.

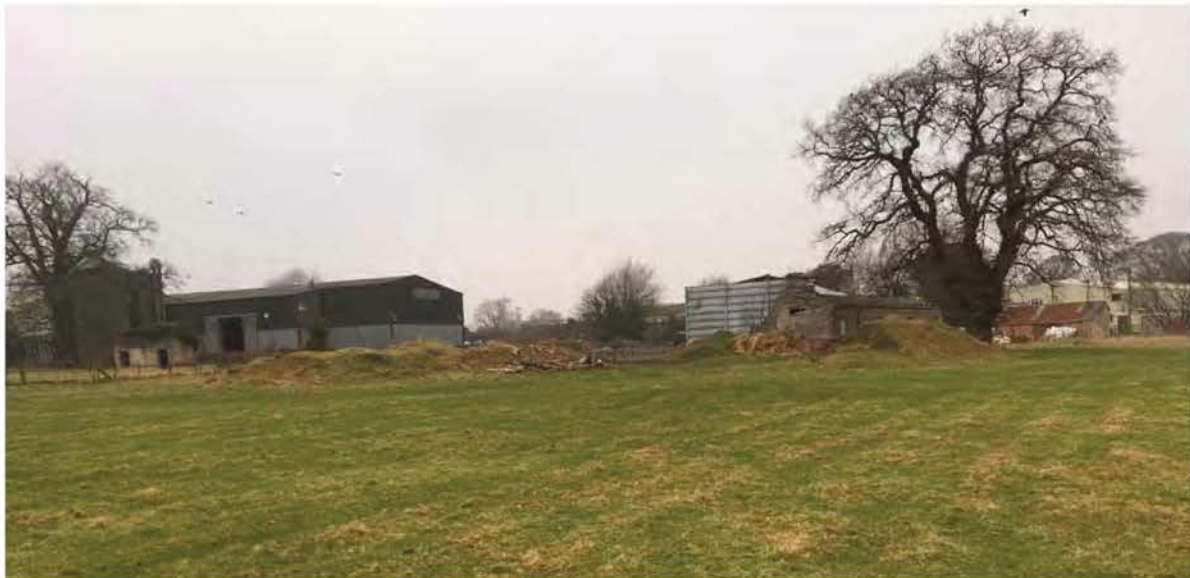
View from centre of site, looking north west. Southern sides of the two structures visible along with mounds of soil/rubble.

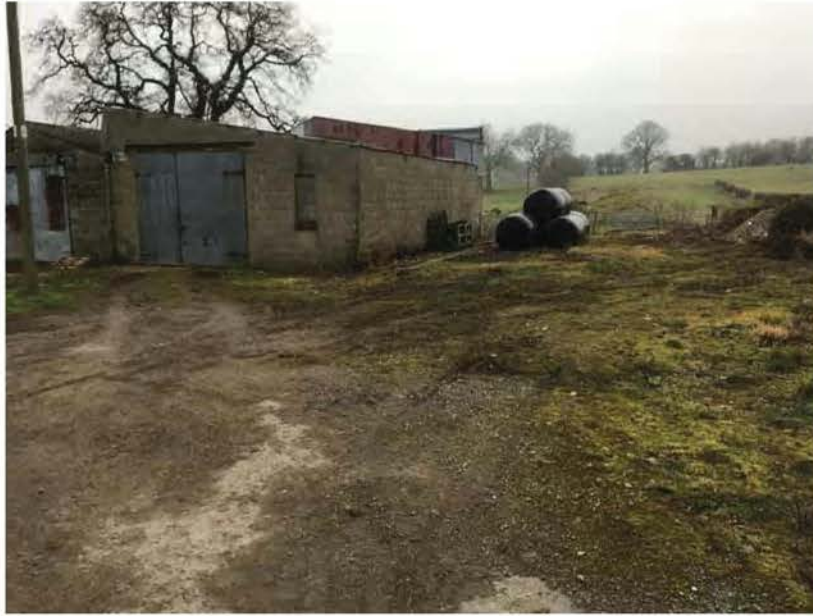
Date	Job No	Made by	Checked by	Sheet No
January 2017	CGN/03835	AP	JAS	04

View looking south from the access point into the site. Showing the rear of the larger structure.

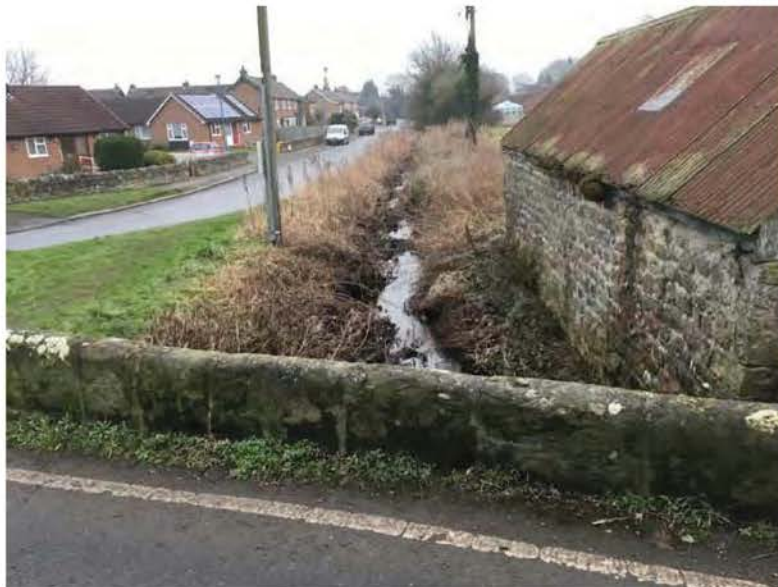
View looking east along the northern border of the site. Showing the rear of the smaller structure and Swinney Beck.
