Phase 2: Site Investigation

Robin Hood Farm, Brompton-on-Swale

S191209

PHASE 2 SITE INVESTIGATION REPORT

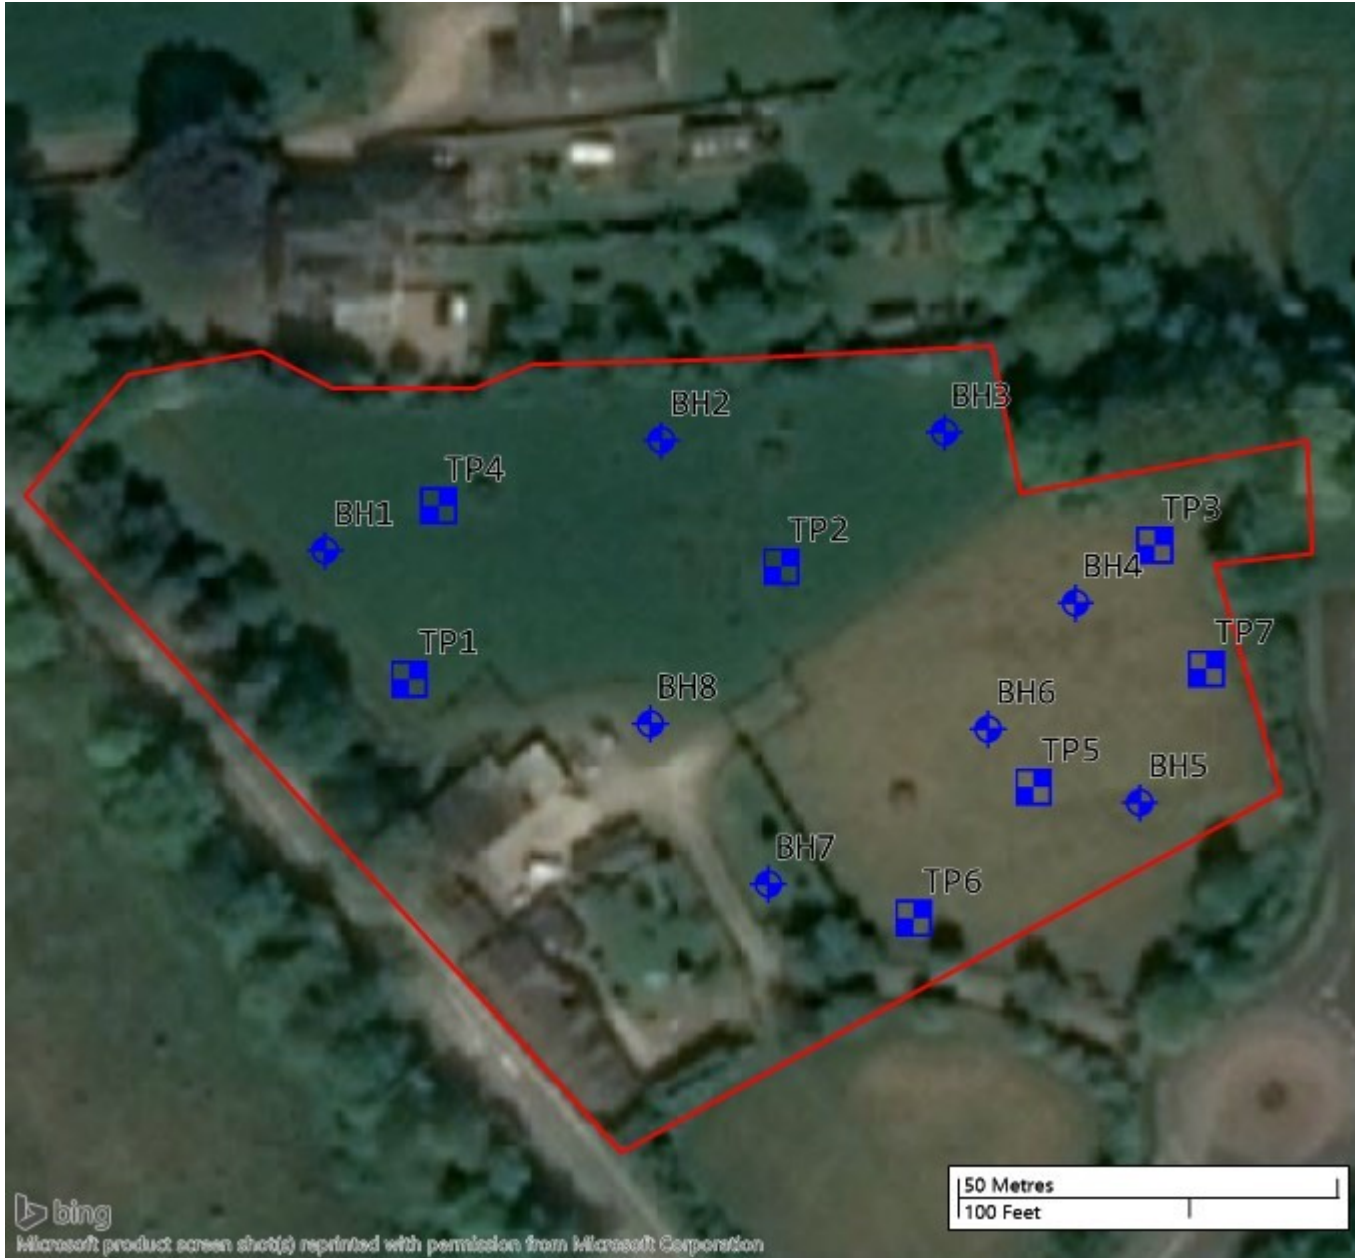
Descriptions of the strata encountered in the boreholes and trial pits together with details of sampling and groundwater are presented in Appendix B of this report. A plan showing the location of the boreholes and trial pits can be found in Appendix A (Figure 2).

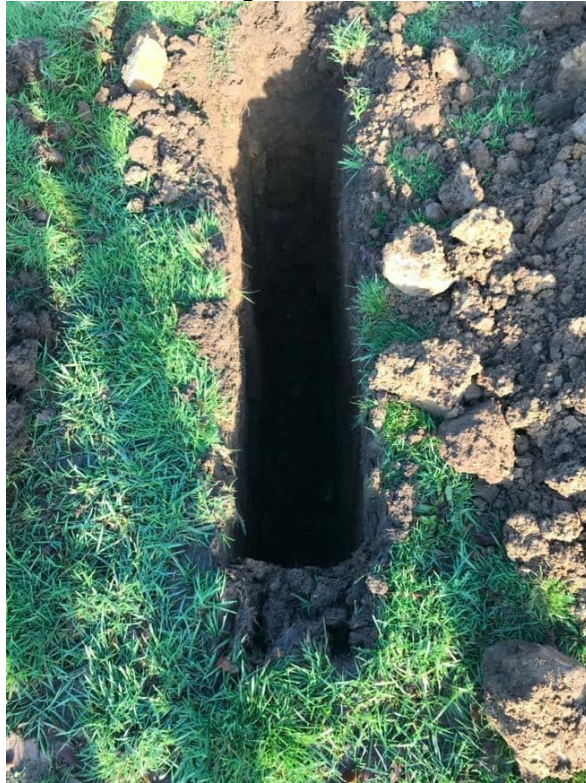
Figure 8: TP6

One soakaway test was undertaken within the base of TP6. The result returned an infiltration rate of 5.41×10^{-6} m/sec. The results are presented in Appendix D.

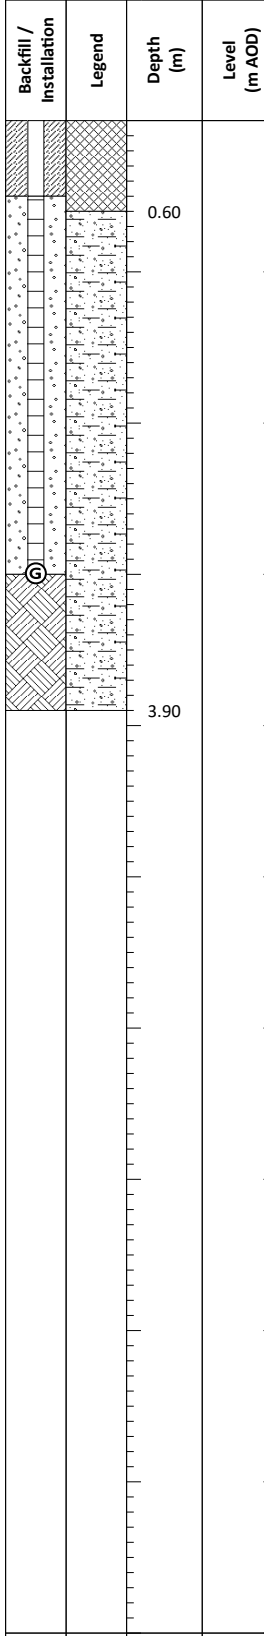
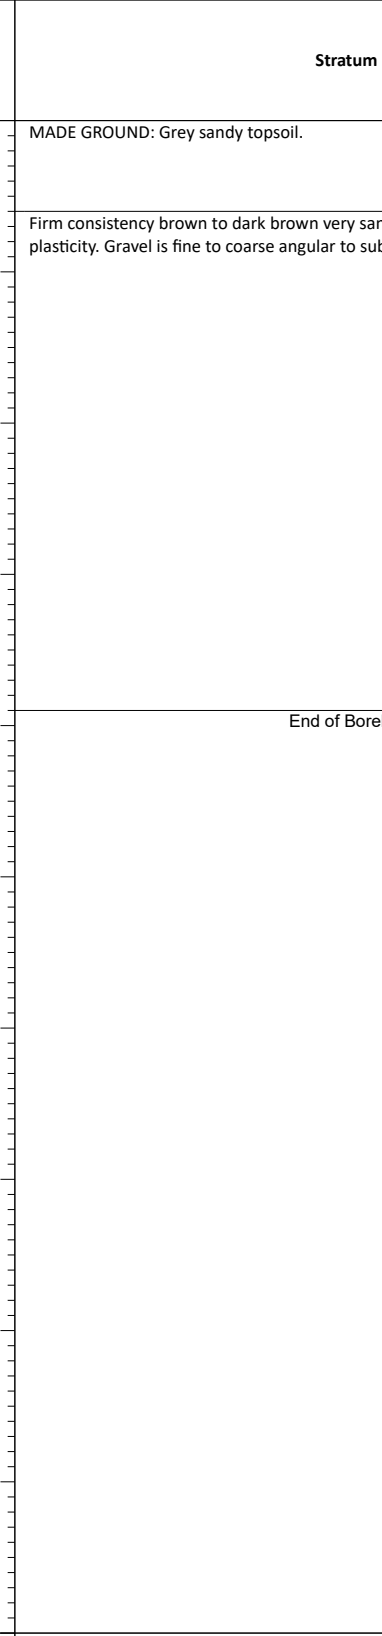
0.60		MADE GROUND: Grey sandy topsoil.	0.20 - 0.40	B+ES		
				Firm consistency brown to dark brown very sandy slightly gravelly medium strength CLAY of low plasticity. Gravel is fine to coarse angular to subangular of sandstone and mudstone.	0.40 - 0.60	B+ES		
					0.80 - 1.00	B+ES		
					1.20	HV		62kPa
					1.40 - 1.60	D		
					1.80 - 2.00	D		
					2.00	HV		73kPa
					2.40 - 2.60	D		
					2.80 - 3.00	D		
					3.00	HV		57kPa
		3.90		End of Borehole at 3.900m	3.70 - 3.90	D	N=50+ (25/50)	
					3.90 - 4.35	SPT (S)

Hole Diameter				Casing Depths		General Remarks	Chiselling			Ground Water				
Depth Base (m)	Diameter (mm)	Depth Base (m)	Diameter (mm)	From (m)	To (m)		Time (hr)	Depth Strike (m)	Depth Casing (m)	Depth Sealed (m)	Time Elapsed (min)	Water Level (m)		
						1.2m hand excavated inspection pit. No Groundwater Encountered.

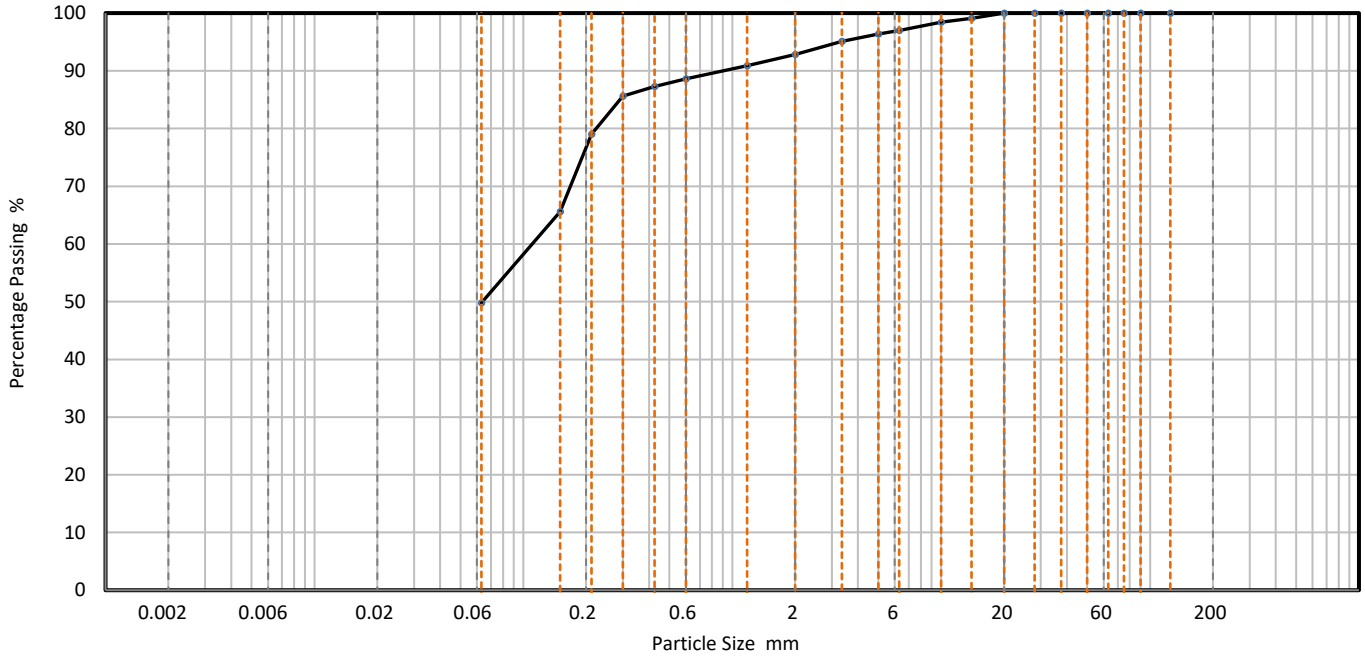
Hole	BH1	Lab sample ID	SLMK202001070
Depth (Top) m	0.80	Test Method	BS 1377 - 2 : 1990 Clause 9.2
Depth (Base) m	1	Soil Description	Brown, slightly gravelly, Very Sandy CLAY
Sample type	B

Sieving		Sedimentation	
Particle Size mm	% Passing	Particle Size mm	% Passing
125	100		
90	100		
75	100		
63	100		
50	100		
37.5	100		
28	100		
20	100		
14	99		
10	98		
6.3	97		
5	96		
3.35	95		
2	93		
1.18	91		
0.6	89		
0.425	87		
0.3	86		
0.212	79		
0.15	66		
0.063	50

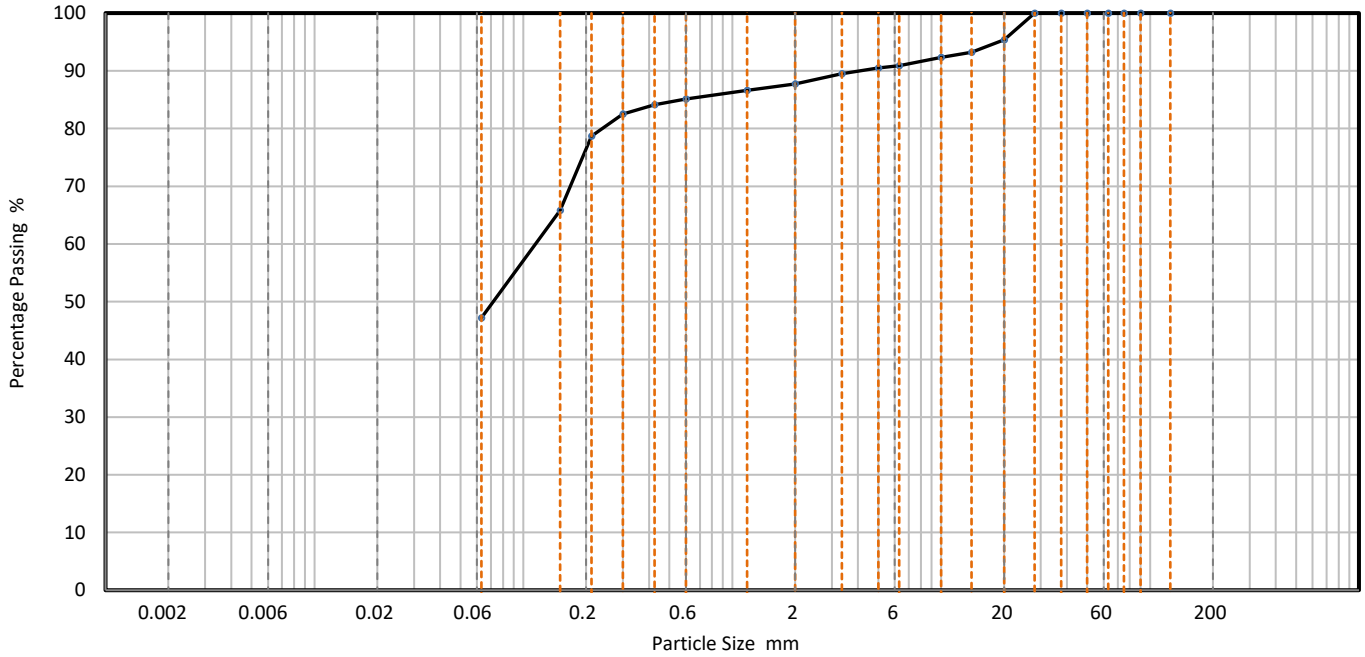
Hole	BH3	Lab sample ID	SLMK202001072
Depth (Top) m	0.80	Test Method	BS 1377 - 2 : 1990 Clause 9.2
Depth (Base) m	1	Soil Description	Brown, slightly gravelly, very sandy CLAY
Sample type	B

Sieving		Sedimentation	
Particle Size mm	% Passing	Particle Size mm	% Passing
125	100		
90	100		
75	100		
63	100		
50	100		
37.5	100		
28	100		
20	95		
14	93		
10	92		
6.3	91		
5	91		
3.35	90		
2	88		
1.18	87		
0.6	85		
0.425	84		
0.3	83		
0.212	79		
0.15	66		
0.063	47

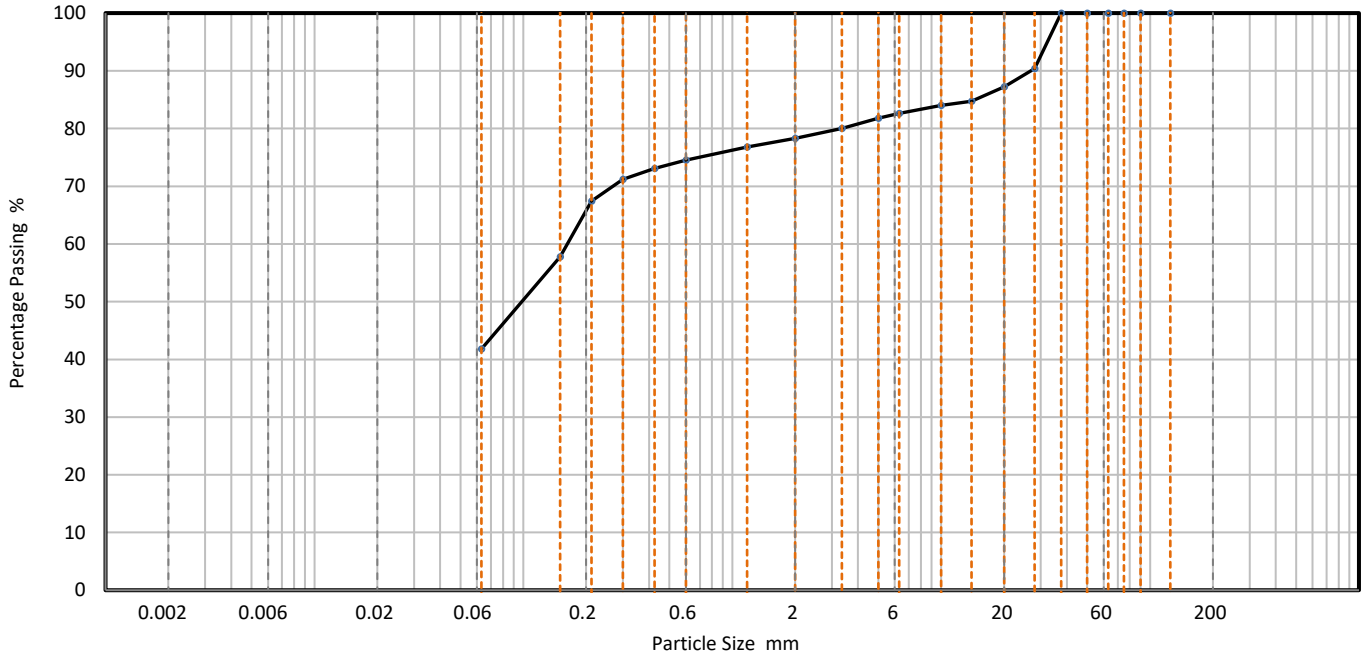
Hole	BH5	Lab sample ID	SLMK202001074
Depth (Top) m	0.80	Test Method	BS 1377 - 2 : 1990 Clause 9.2
Depth (Base) m	1	Soil Description	Brown, slightly gravelly, Very Sandy CLAY
Sample type	B

Sieving		Sedimentation	
Particle Size mm	% Passing	Particle Size mm	% Passing
125	100		
90	100		
75	100		
63	100		
50	100		
37.5	100		
28	90		
20	87		
14	85		
10	84		
6.3	83		
5	82		
3.35	80		
2	78		
1.18	77		
0.6	75		
0.425	73		
0.3	71		
0.212	67		
0.15	58		
0.063	42

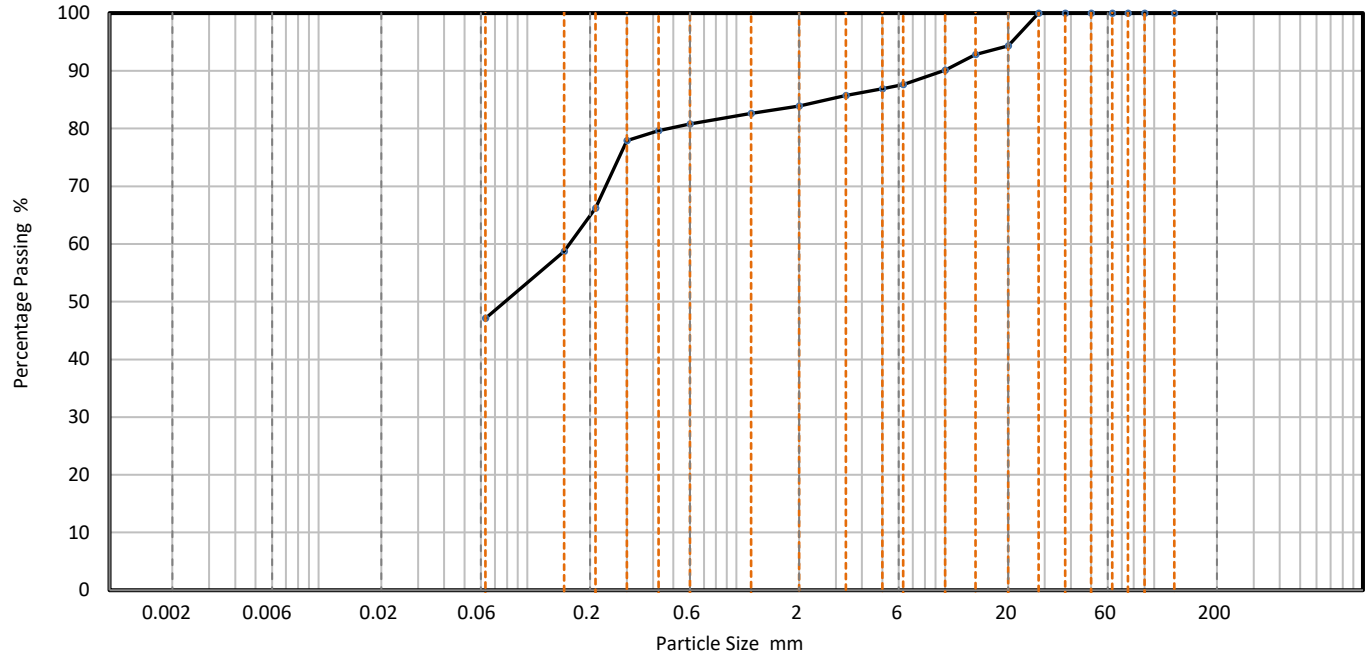
Hole	BH7	Lab sample ID	SLMK202001076
Depth (Top) m	0.80	Test Method	BS 1377 - 2 : 1990 Clause 9.2
Depth (Base) m	1	Soil Description	Brown, slightly gravelly, Very Sandy CLAY
Sample type	B

Sieving		Sedimentation	
Particle Size mm	% Passing	Particle Size mm	% Passing
125	100		
90	100		
75	100		
63	100		
50	100		
37.5	100		
28	100		
20	94		
14	93		
10	90		
6.3	88		
5	87		
3.35	86		
2	84		
1.18	83		
0.6	81		
0.425	80		
0.3	78		
0.212	66		
0.15	59		
0.063	47

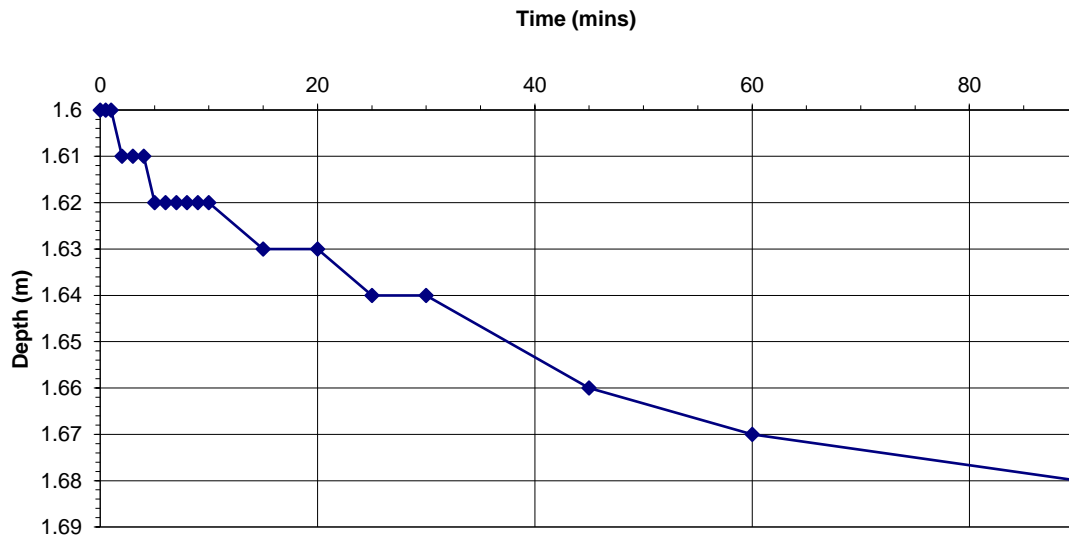
Client: Billinghamurst George & Partners			
Site: Robin Hood Farm, Brompton-on-Swale			
Job No:	S191209		
Pit No:	TP6	Test No:	1
CALCULATION OF SOIL INFILTRATION RATE			
Time (min)	Depth (m)	Pit Dimensions	Length (m) = 1.50
0	1.6		Width (m) = 0.45
0.5	1.6		Depth (m) = 2.00
1	1.6		
2	1.61	Depth at start of test (m) =	1.600
3	1.61	Depth at end of test (m) =	1.680
4	1.61	75% level (m) =	1.620
5	1.62	50% Effective Depth	0.360
6	1.62	25% level (m) =	1.660
7	1.62		
8	1.62	Base area of pit (m²) =	0.675
9	1.62	V_{p75-25} (m³) =	0.027
10	1.62	a_{n50} (m²) =	2.079
15	1.63		
20	1.63	From the graph:	
25	1.64	tp 75 (min) =	5
30	1.64	tp 25 (min) =	45
45	1.66		
60	1.67	Soil infiltration rate, f, (m/s) =	5.41E-06 normal test
90	1.68		
120			
150		Input by: LR	Date: 08/12/2019
180		Checked by: LC	Date: 08/12/2019
