Job name: Goldsborough

Note No: TN002 Rev C

Subject: Drainage Strategy

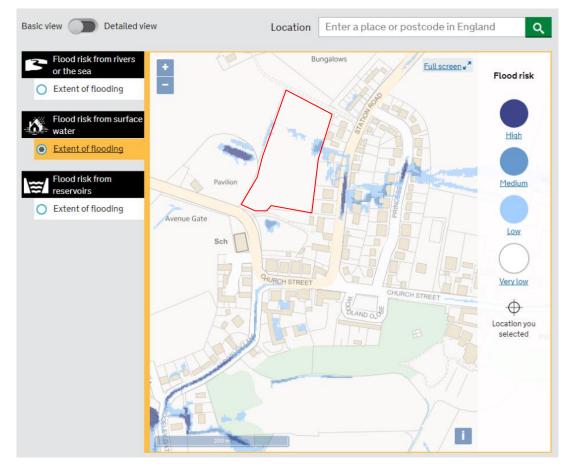
Figure 1: Environment Agency Flood Risk from Surface Water Map

2.1.6 An extract of the map, provided below in Figure , suggests that the site is at very low to medium risk from surface water flooding.

- 2.1.7 The low to medium level surface water flooding risk appears to relate to an overland flow route from the higher ground to the west of the site, towards the houses to the east. There is also an area at high risk of surface water flooding close to the western site boundary within the cricket ground.
- 2.1.8 Photos taken following the heavy rainfall at the end of 2015 confirm that surface water flooding did occur in broadly the areas predicted by the EA modelling (Photo 1).

- 2.1.9 The predicted depth of flooding on site and in the cricket ground from the EA website is less than 300mm. For the areas at higher risk of flooding, the predicted velocity of the flood water is less than 0.25 m/s. For the areas at lower risk of flooding, some of the surface water flood velocities are in excess of 0.25 m/s, directed eastwards across the site towards the existing housing.
- 2.1.10 Since 2015 and the EA modelling exercise, land drains have been installed in the field bordering the north west side of the site by the farmer. These collect at a manhole on the western side of the site and discharge via a land drain to the north. This is understood to connect to surface watercourses to the north east of the site and has reduced the overland flow across the site.
- 2.1.11 The risk of surface water flooding is therefore considered low to medium.

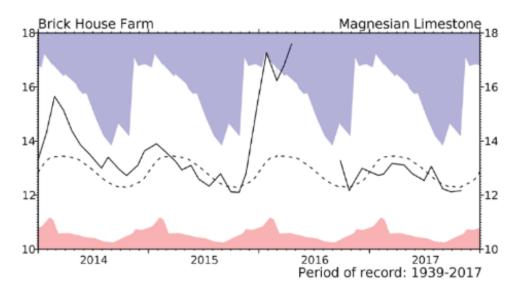
Figure 1: Magnesian Limestone Hydrograph

- 2.1.8 The water table will also vary seasonally. CEH monitor key boreholes across the country including a borehole in Wharfedale which penetrates the Magnesian Limestone, approximately 15km to the south east. The Brick House Farm borehole is located on an outcrop of the Brotherton Formation with the River Wharfe to the east. The elevation of the river is c. 7m aOD and the site is on the valley side at c. 53m aOD. The seasonal range in groundwater levels would be expected to be greater in such a scenario than at the site in Goldsborough. The hydrograph from the borehole shows that the seasonal maxima generally occur between January and February with the minima around September with a range of c. 1.5m.

- 2.1.9 Collating this data, and allowing a greater variation is seasonal groundwater levels, it has been estimated that there will be at least 6m of unsaturated zone beneath the base of any soakaways at this site. This is 5m more than is generally required and this estimate has been made using conservative estimates. The data has been collated schematically as shown overleaf.
- 2.1.10 Seasonal measurement of groundwater levels is deemed unnecessary at the site and it concluded that there will be sufficient unsaturated zone beneath any soakaways that may be installed, subject to the findings of the further testing.

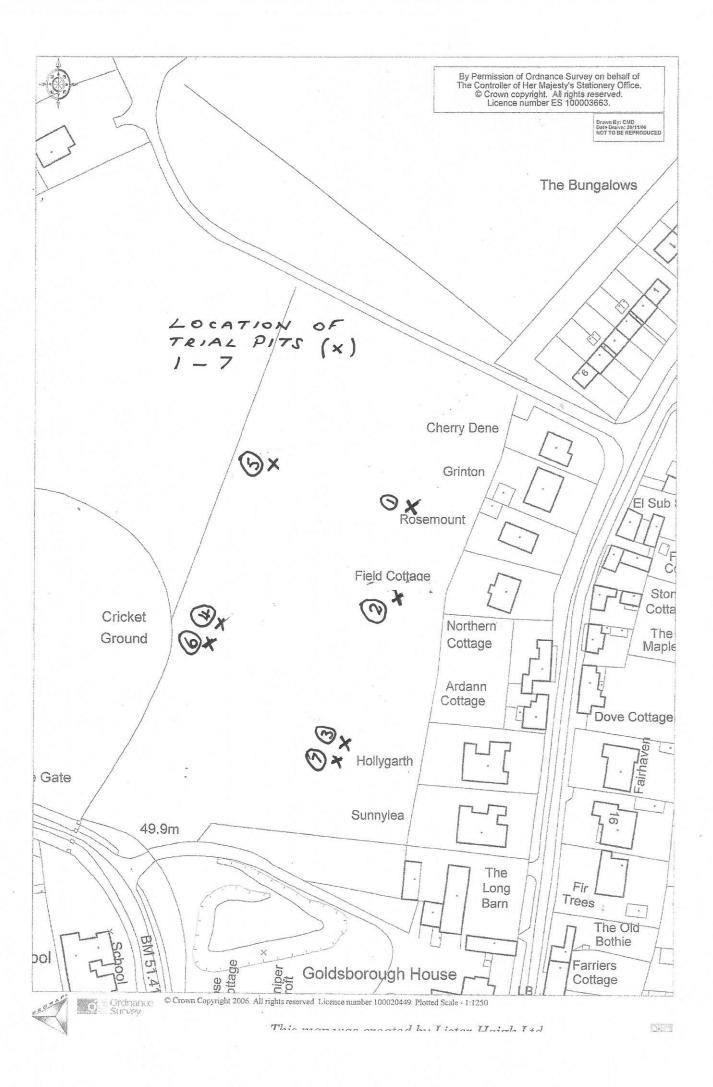
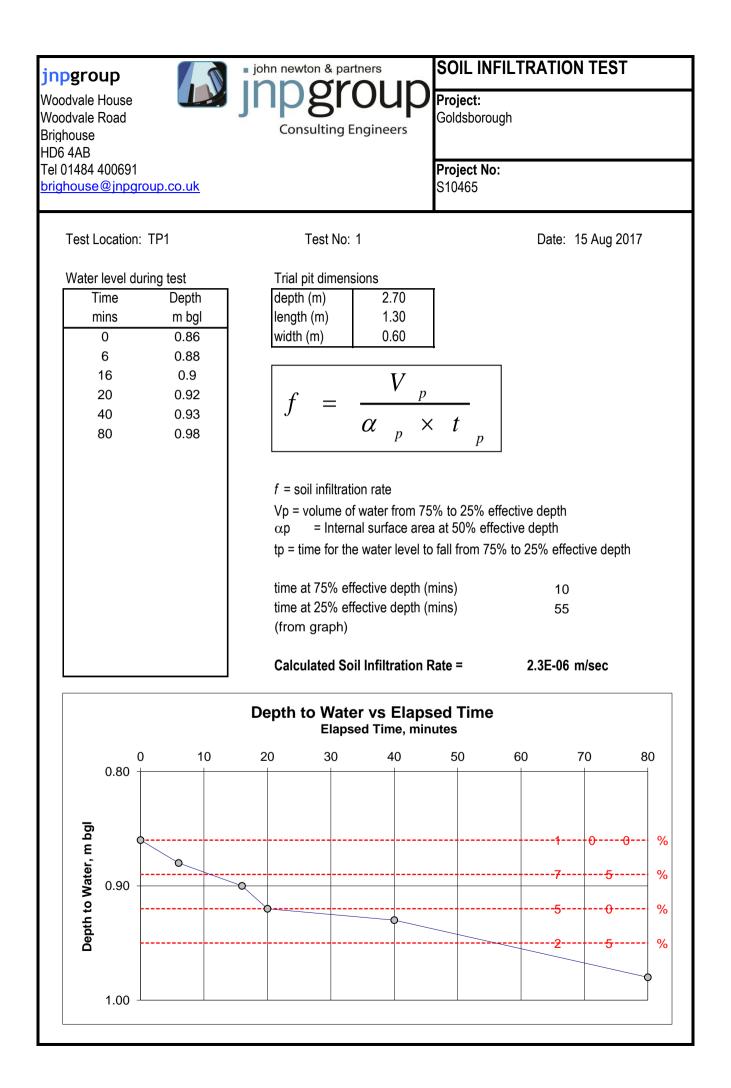
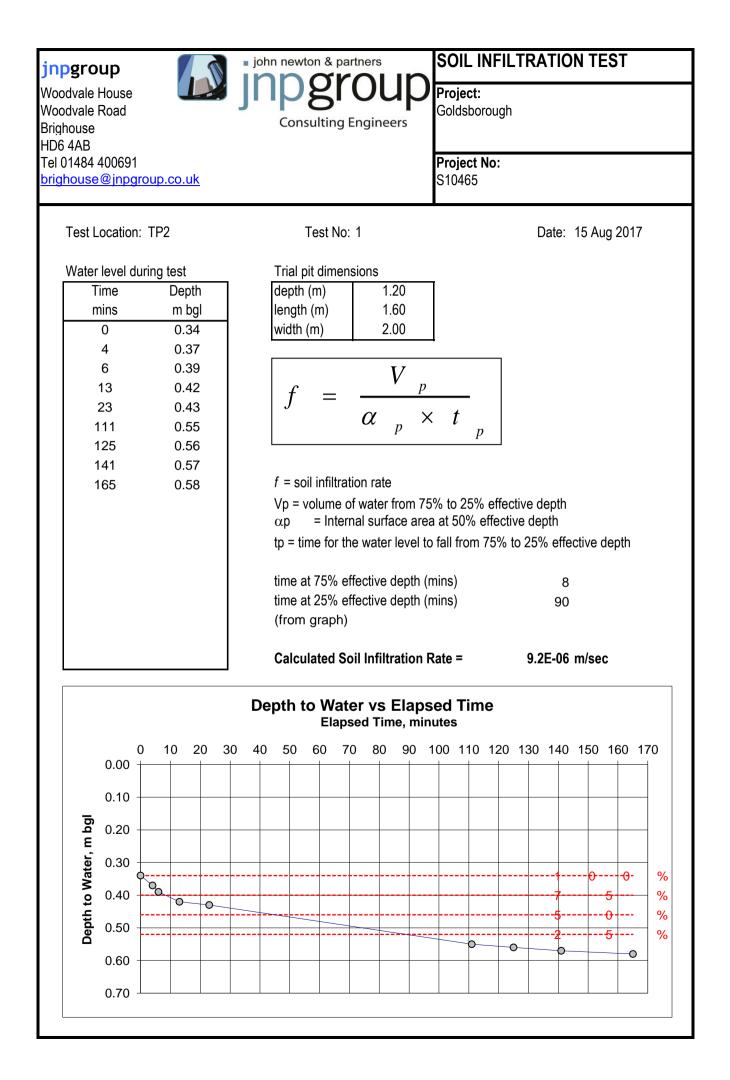
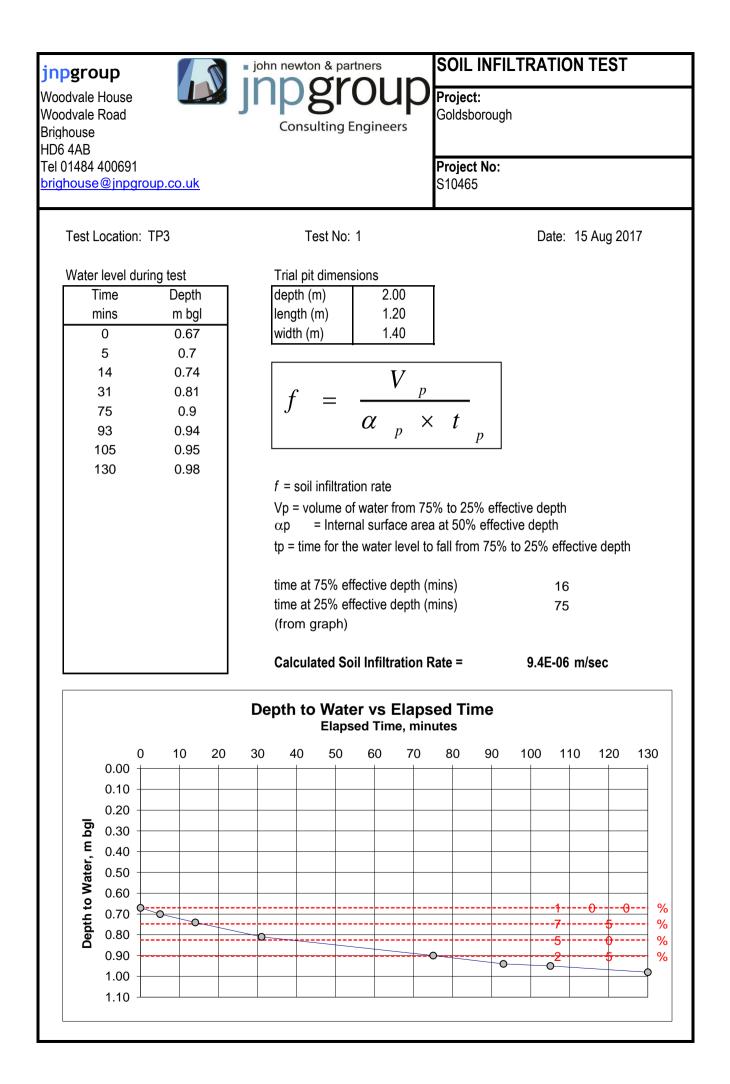
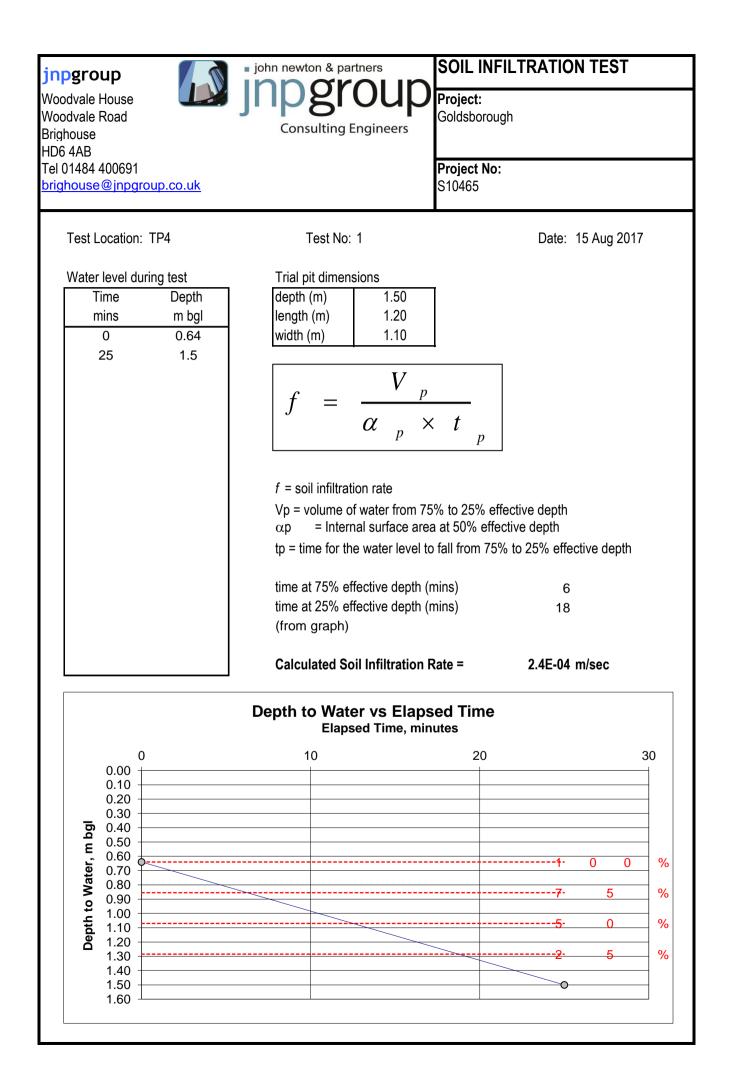
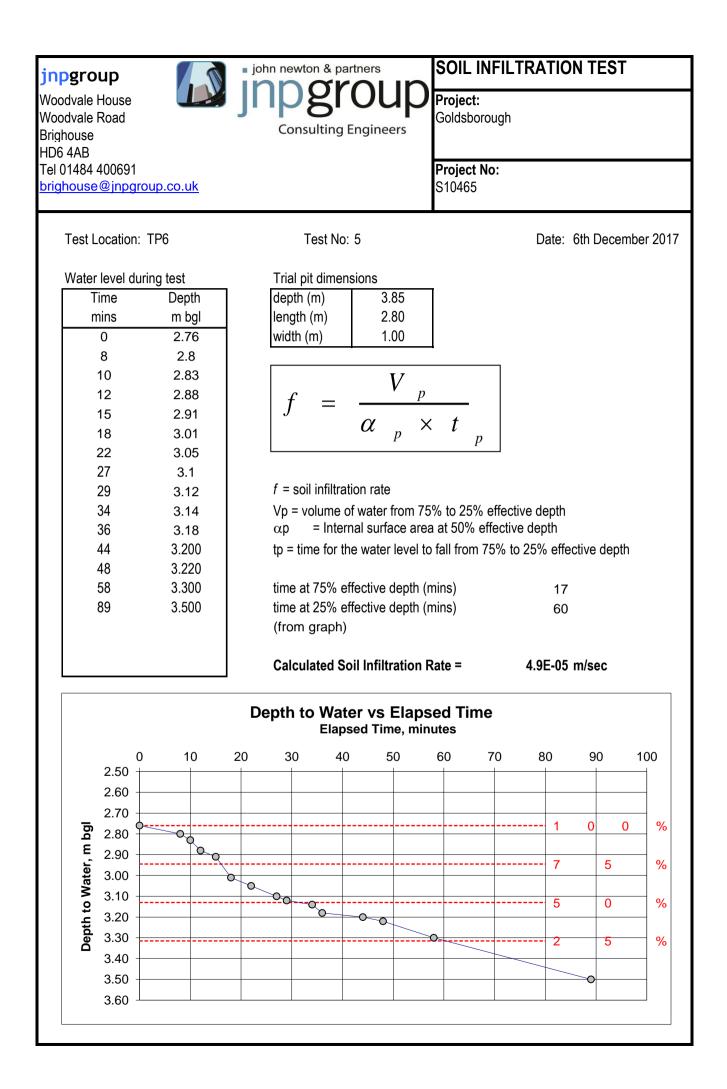
Appendix B Infiltration Testing Results

Top of strata (mm bgl)	Base of strata (mm bgl)	Description
Test Hole 1		
0	400	Loam topsoil
400	800	Compacted subsoil (sand & clay)
800	1800	Blue clay
1800	2700	Red clay mixed with limestone rock
Test Hole 2	2700	
0	400	Loam topsoil
400	900	Subsoil salmon coloured limestone mix of clay & rock
900	1200	Limestone bed rock
Test Hole 3	1200	
0	400	Loam Topsoil
400	900	Compacted sand & clay subsoil mix
900	1500	Red clay mixed with fragmented rock
1500	2000	Limestone bedrock
Test Hole 4	2000	
0	400	Loam topsoil
400	1500	Limestone bedrock
Test Hole 5	1500	
0	400	Loam topsoil
400	1600	Clay based subsoil
1600	2100	Compacted clay/ sand/ fragmented rock on to bedrock
Test Hole 6 (adjacent to		Compacted day, sand, hagmented rock on to bedrock
	400	Loam topsoil
400	3850	Limestone bedrock
Test Hole 7 (adjacent to		
0	400	Loam topsoil
400	900	Compacted sand and clay subsoil mix
900	1500	Red clay subsoil mix with rock fragments
1500	2800	Limestone bedrock

Table 2: Infiltration test results						
Location	Geology	Testing date	Infiltration rate (m/s)			
TP4		August 2017	2.4 x 10 ⁻⁴			
TP6	Topsoil overlying		4.9 x 10⁻⁵			
	limestone.	December 2017	5.5 x 10⁻⁵			
			7.6 x 10 ⁻⁵			
TP1		August 2017	2.3 x 10 ⁻⁶			
TP2	Topsoil overlying superficial deposits overlying limestone	August 2017	9.2 x 10 ⁻⁶			
TP3		August 2017	9.4 x 10 ⁻⁶			
TP7		December 2017	6.1 x 10 ⁻⁶

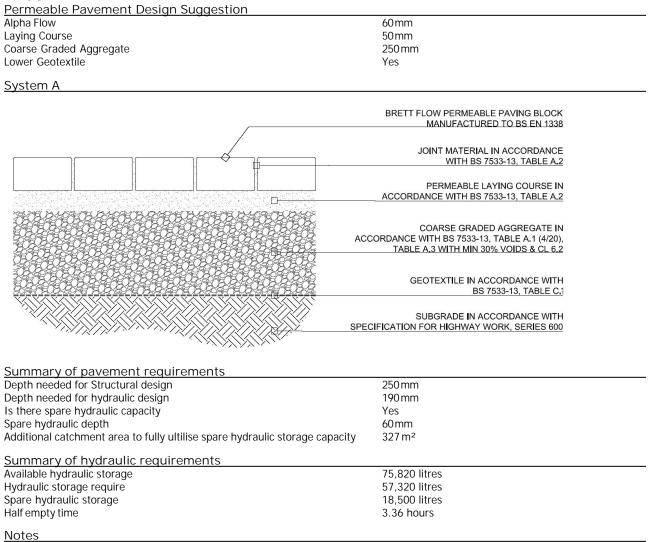
Suggested Pavement Solution

The above calculations were based upon a level site.
